Fischer Landing Town of Century Sedimentation Study June 2022

Water Resource Associates, LLC

Annotated Aerial Photography of Sedimentation Study Area - 1940 to 2019

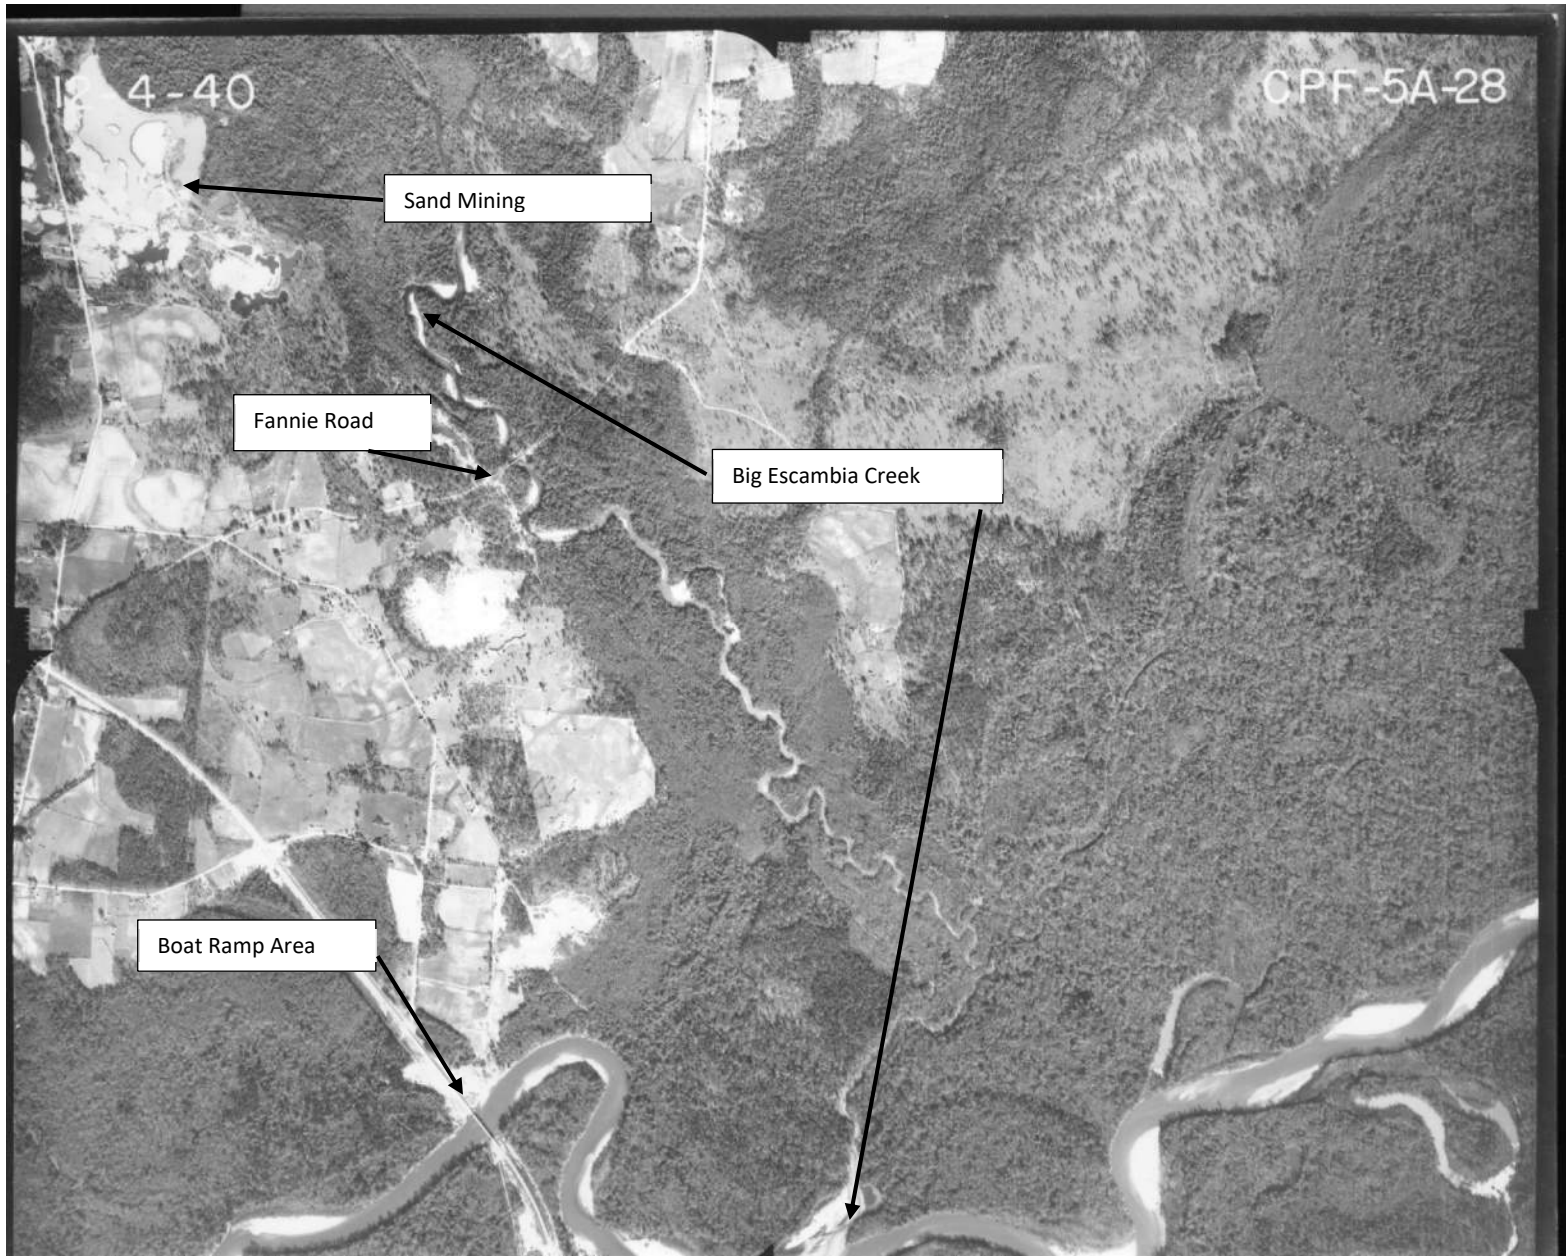
Aerial photography from December 12, 1940 is the earliest available from the University of Florida data archive. The Big Escambia Creek channel is visible as a winding small tributary discharging upstream of the boat ramp site. There are sand bar signatures in the Creek that represent alternating erosion and sedimentation processes.

The bottom of the photograph does have a white sand signature at the discharge point and what appears to be a “delta” type sandbar across the discharge point. The standing sand bars down river along the inside curves (looking downstream) are indicative of a middle course river section as are some visible ox-bow features in both floodplains for Big Escambia Creek and Escambia River.

The signature of the SR 4 corridor at the boat ramp location indicates open soils along the corridor, possibly indicating recent construction. The large area of open soil near the river might also indicate the primary construction location for the bridge crossing.

1940 Aerial Photograph

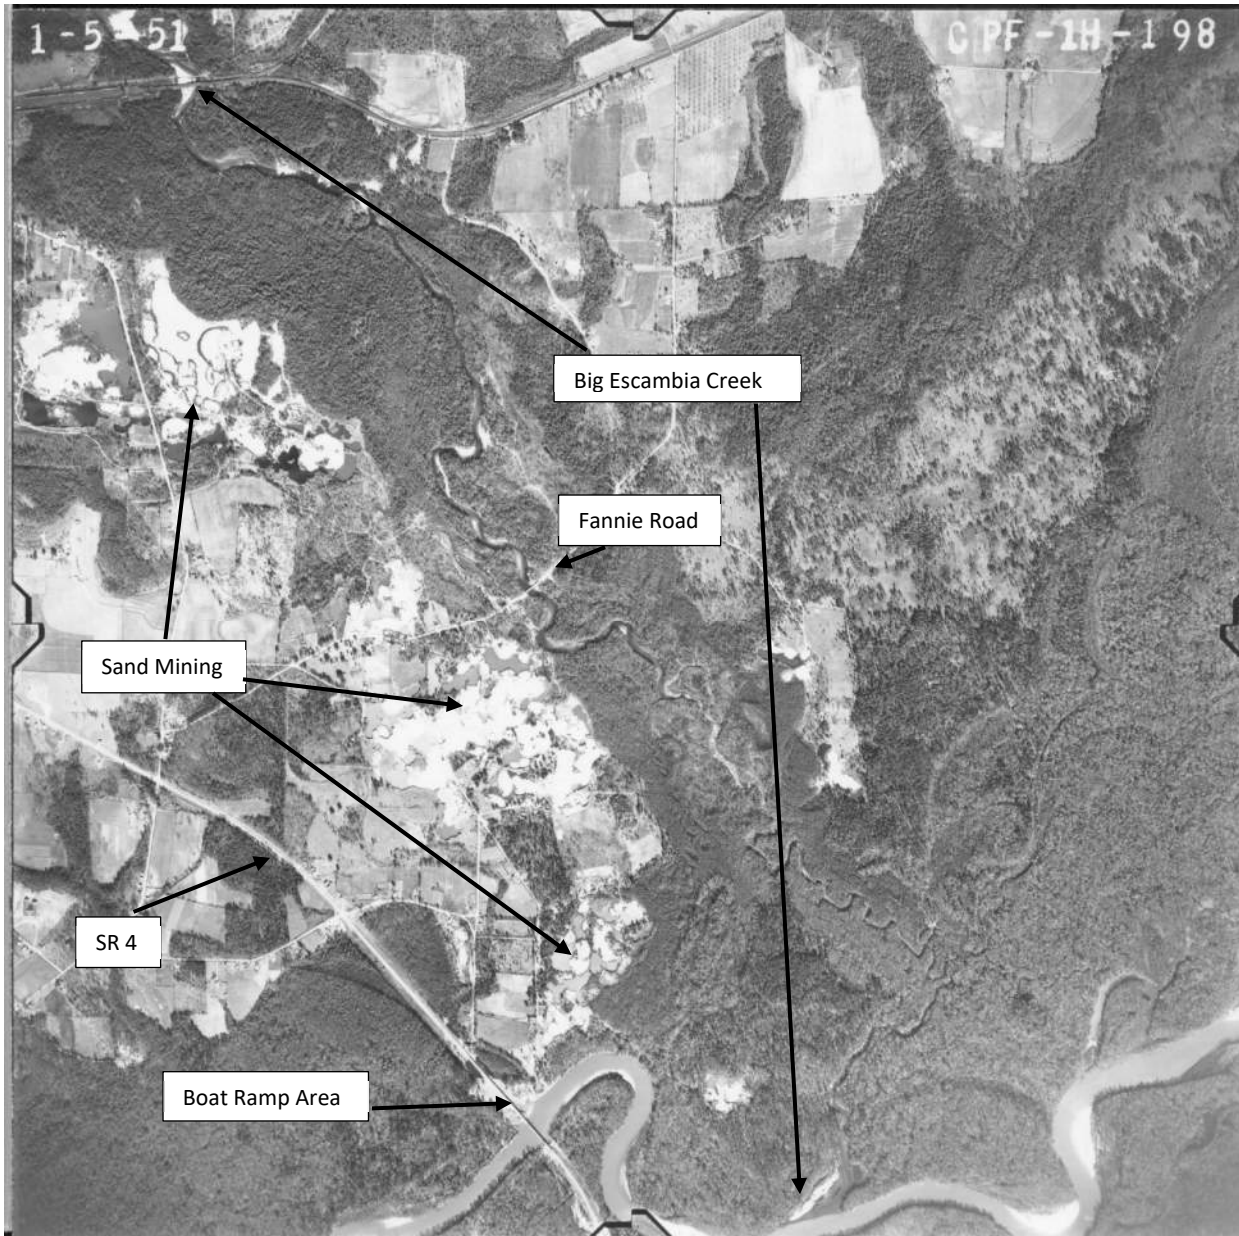
In the January 5, 1951 aerial photo, the delta at the mouth of the Creek is still in place, but the mouth of the Creek is wider than prior with open water visible. Sandbars are in the same locations along the river, but not as large. This indicates higher water level than the 1940 aerial.

January 5 1951 Aerial Photograph

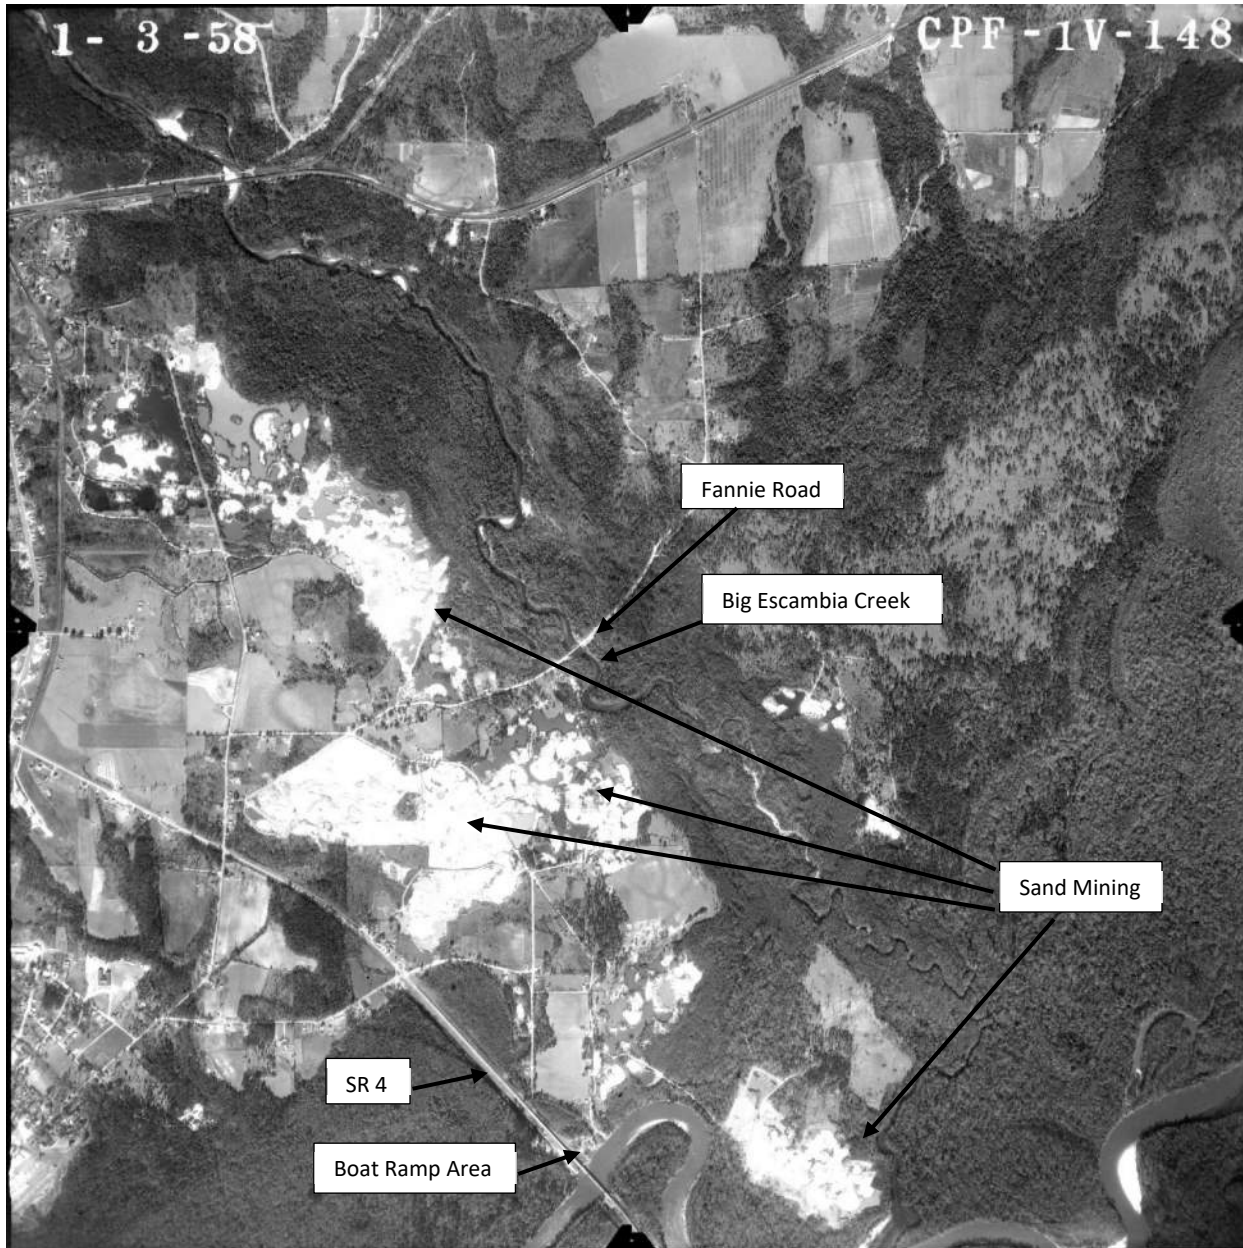
1958 Aerial Photograph

January 3 1958

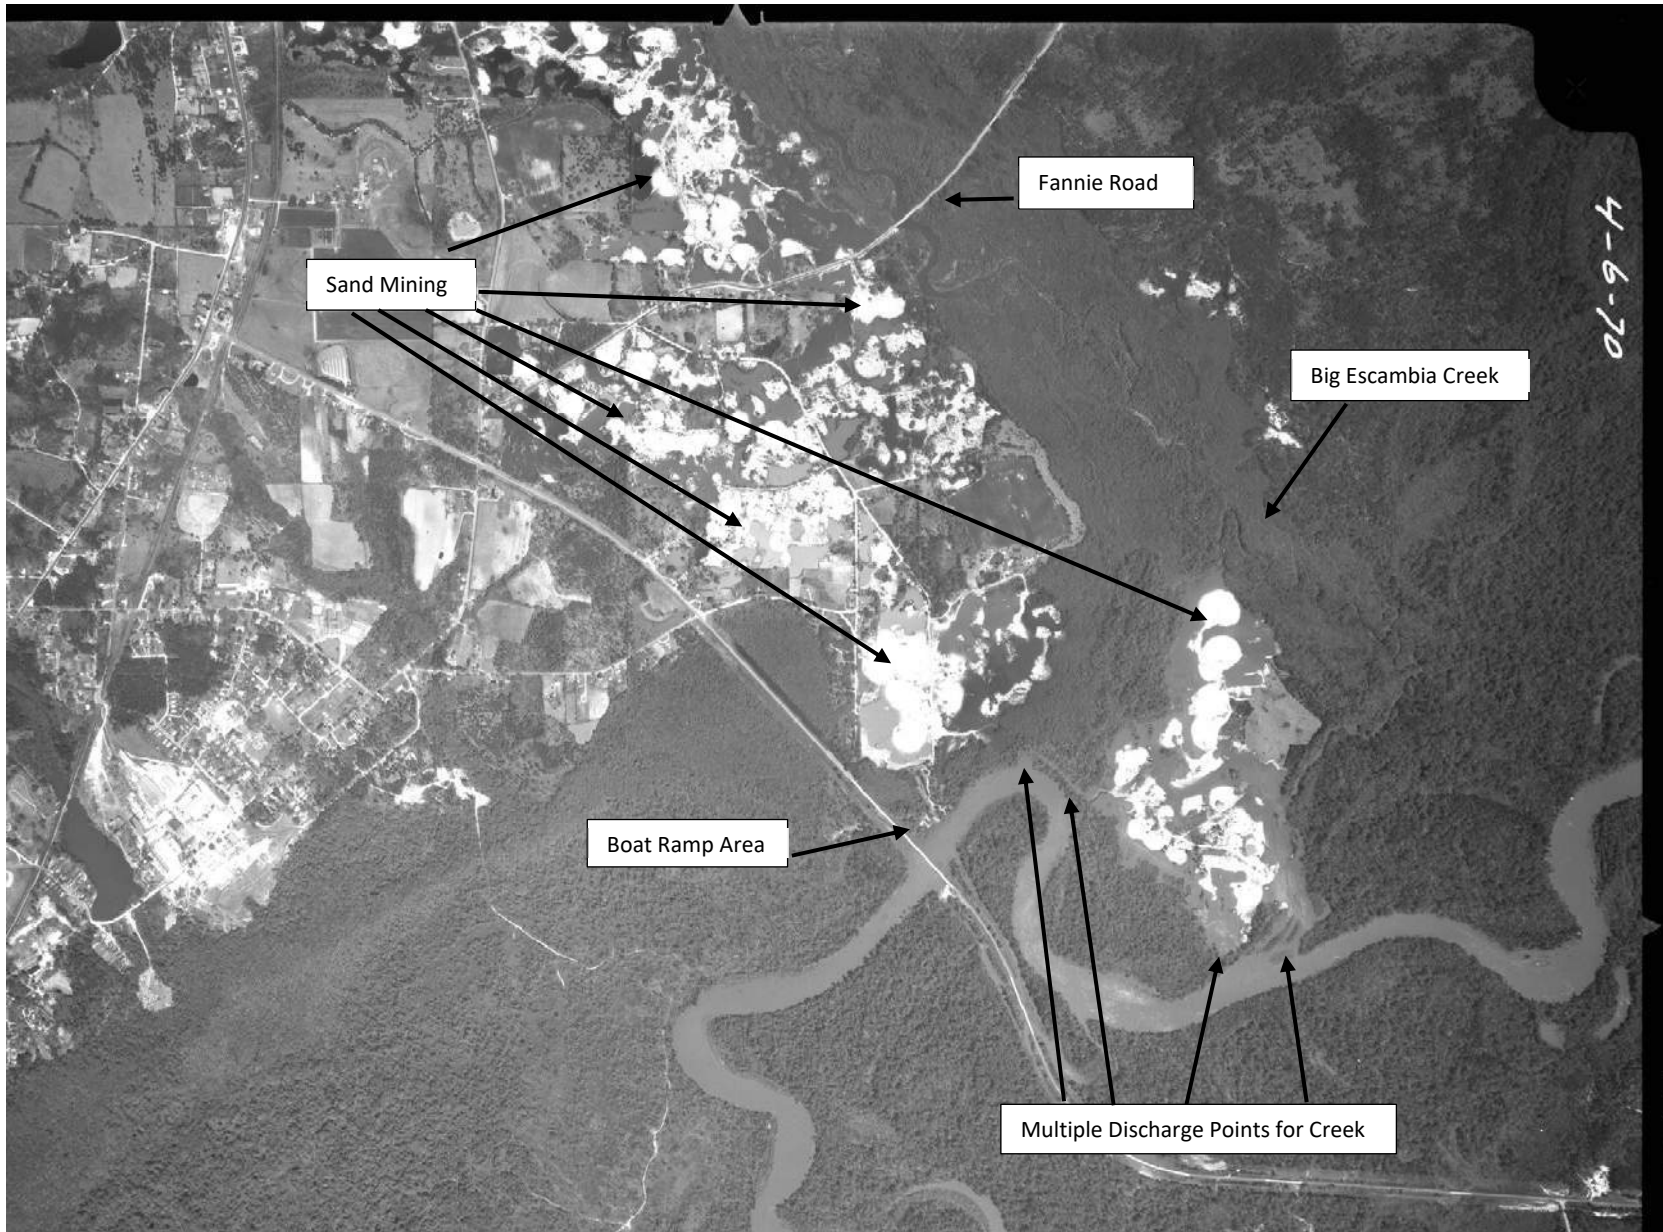
1970 Aerial Photograph

Using measurement tools on the 1970 aerial photograph, the west sand mining area visible in this aerial amounts to approximately 1.6 square miles. High water in 1970 inundated the sand mine areas and appears to overtop the berm between the west sand mine and Big Escambia Creek just south of Fannie Road.

April 6, 1970: High Water Event – Sand Mines Flooded

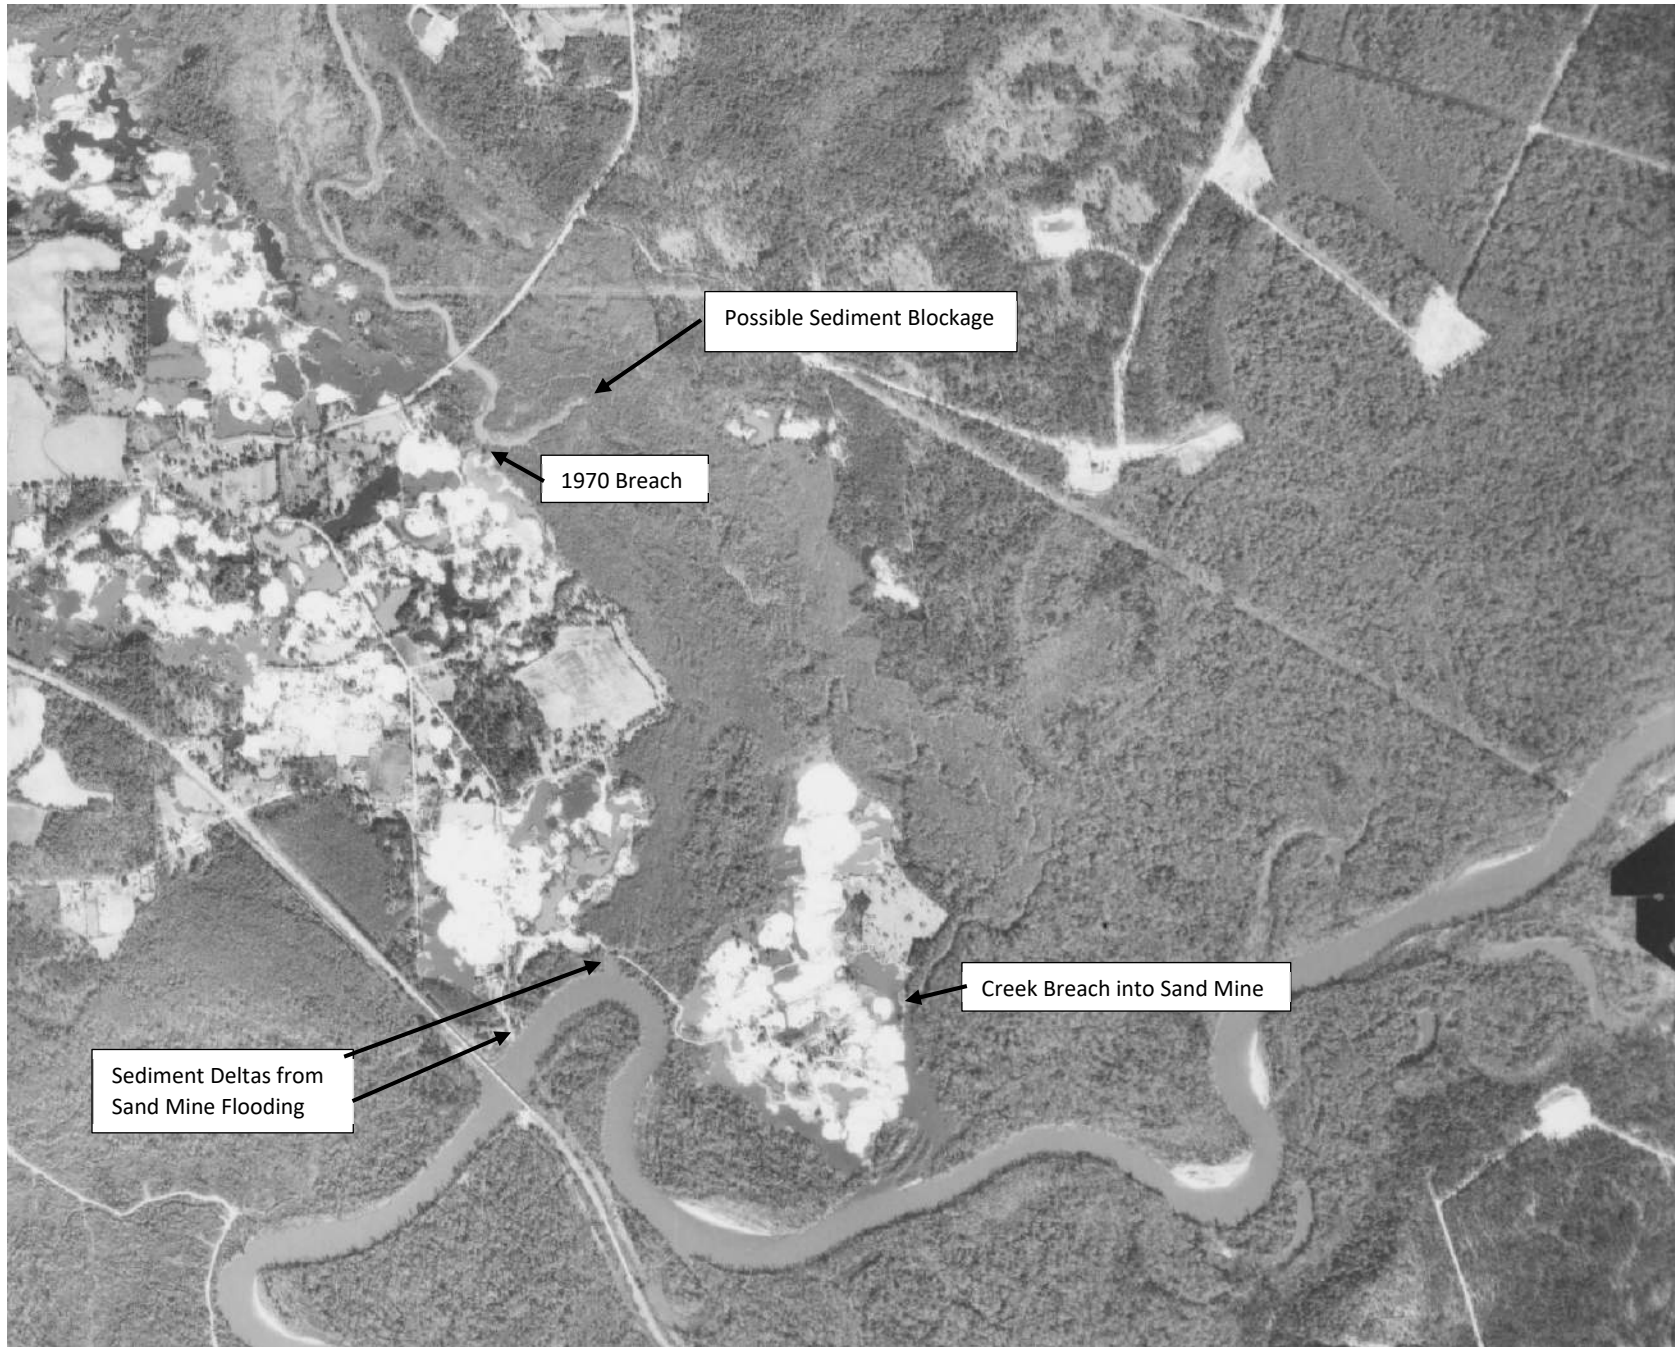
1973 Aerial Photograph

The 1973 aerial is again a high water event and indicates several breaches from the Creek into existing sand mines between Fannie Road to the discharge point of the Creek into the Escambia River. There is a small area south of Fannie Road that appears to be a sediment blockage to the main channel of the Creek, but not a total occlusion. Water remains in the east and west sand mines, and there is evidence of some sediment entering the Escambia River near the east sand mine area.

January 22, 1973: Big Escambia Creek Breach into Eastern Sand Mine Area. Sediment blocking Historic Big Escambia Creek Channel near Fannie Road- flooding western sand mine.

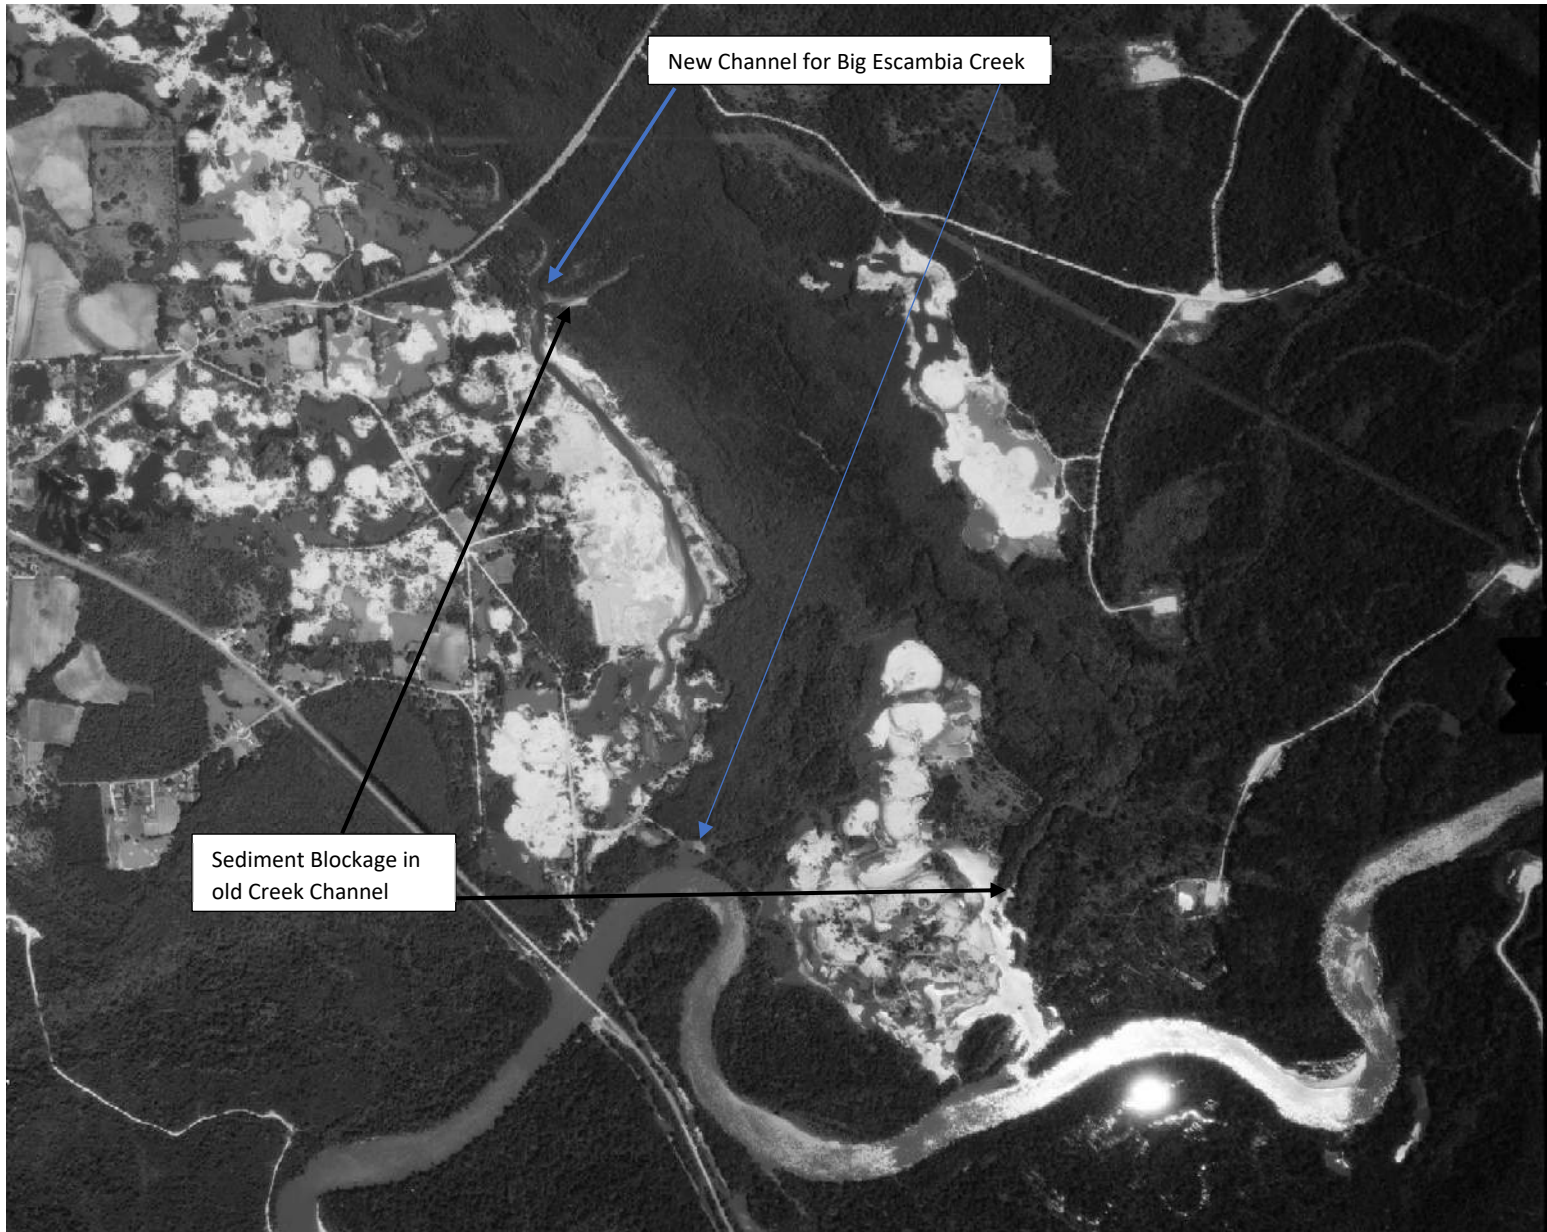
1978 Aerial Photograph

By 1978, Big Escambia Creek has rerouted through the west sand mine area south of Fannie Road. A sand occlusion is visible in the historic Creek channel. The remainder of the historic Creek channel also does not appear to have any open water visible. This new flow channel remained in place until approximately December 2004.

April 21 1978: Erosion Channel for Big Escambia Creek in Western Sand Mine

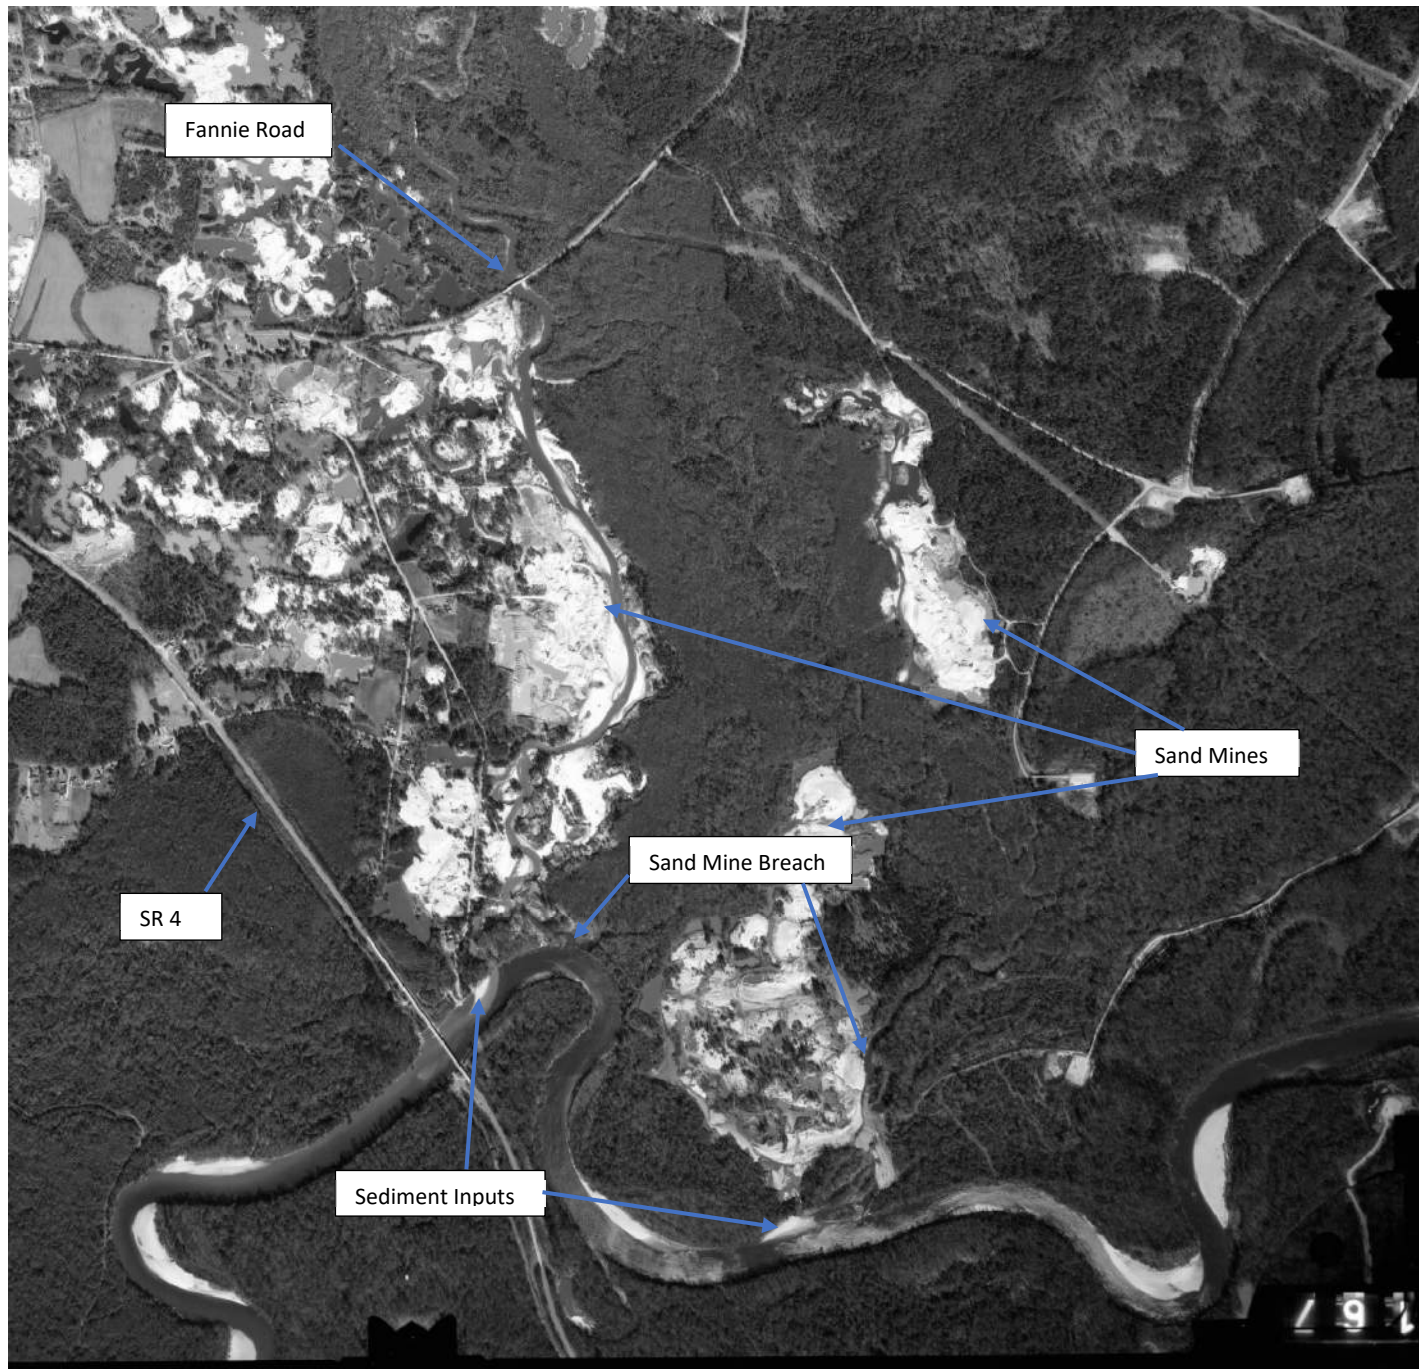
1981 Aerial Photograph

February 2, 1981 – Low Water Event with Visible Sand Deposits.

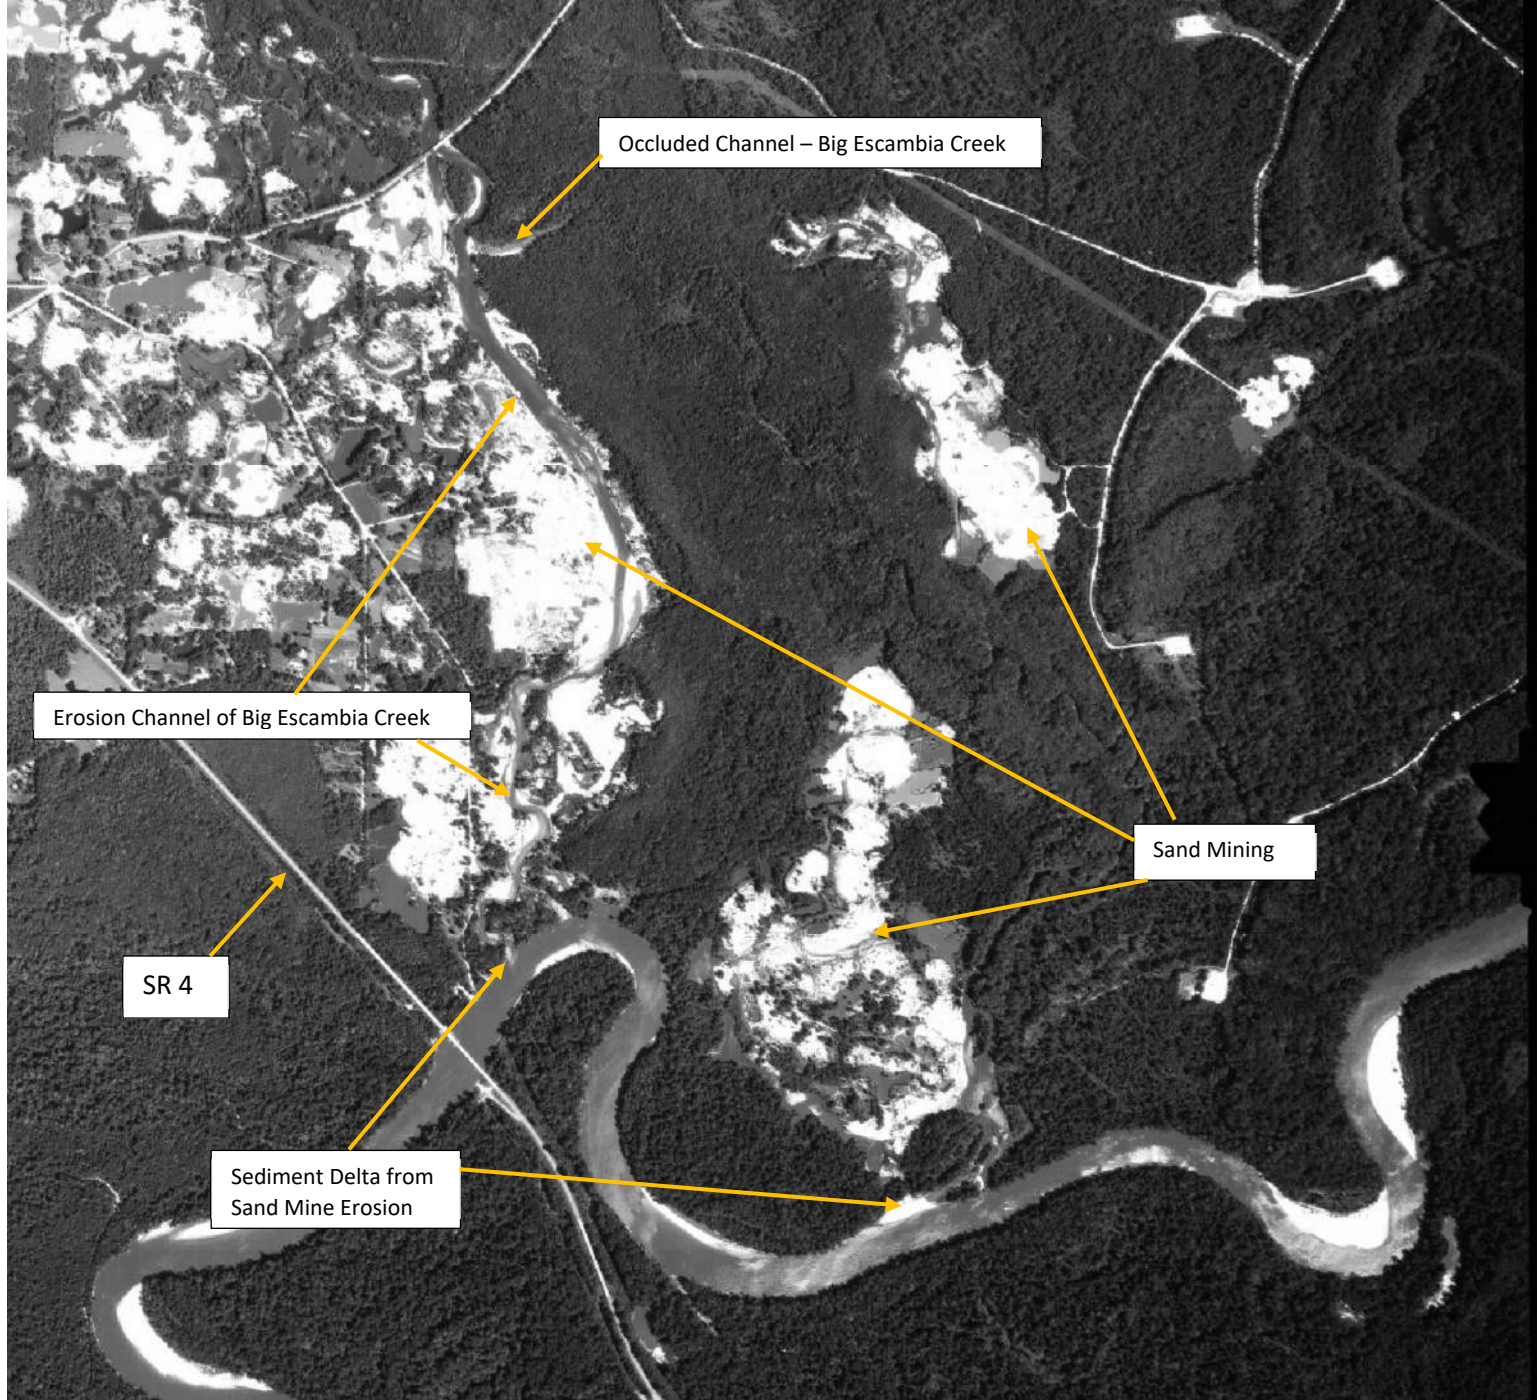
1983 Aerial Photograph

In the 1983 aerial, the delta extends into the river even on the outer curve of the river. This could indicate the force of sediment being put into the river or the large amount deposited. At the same time, the eastern sand mine has a large deposit of sediment at the mouth of the Creek as it enters the river. The sand mine upstream of the mouth was also breached allowing high water to move sediment downstream.

September 22, 1983

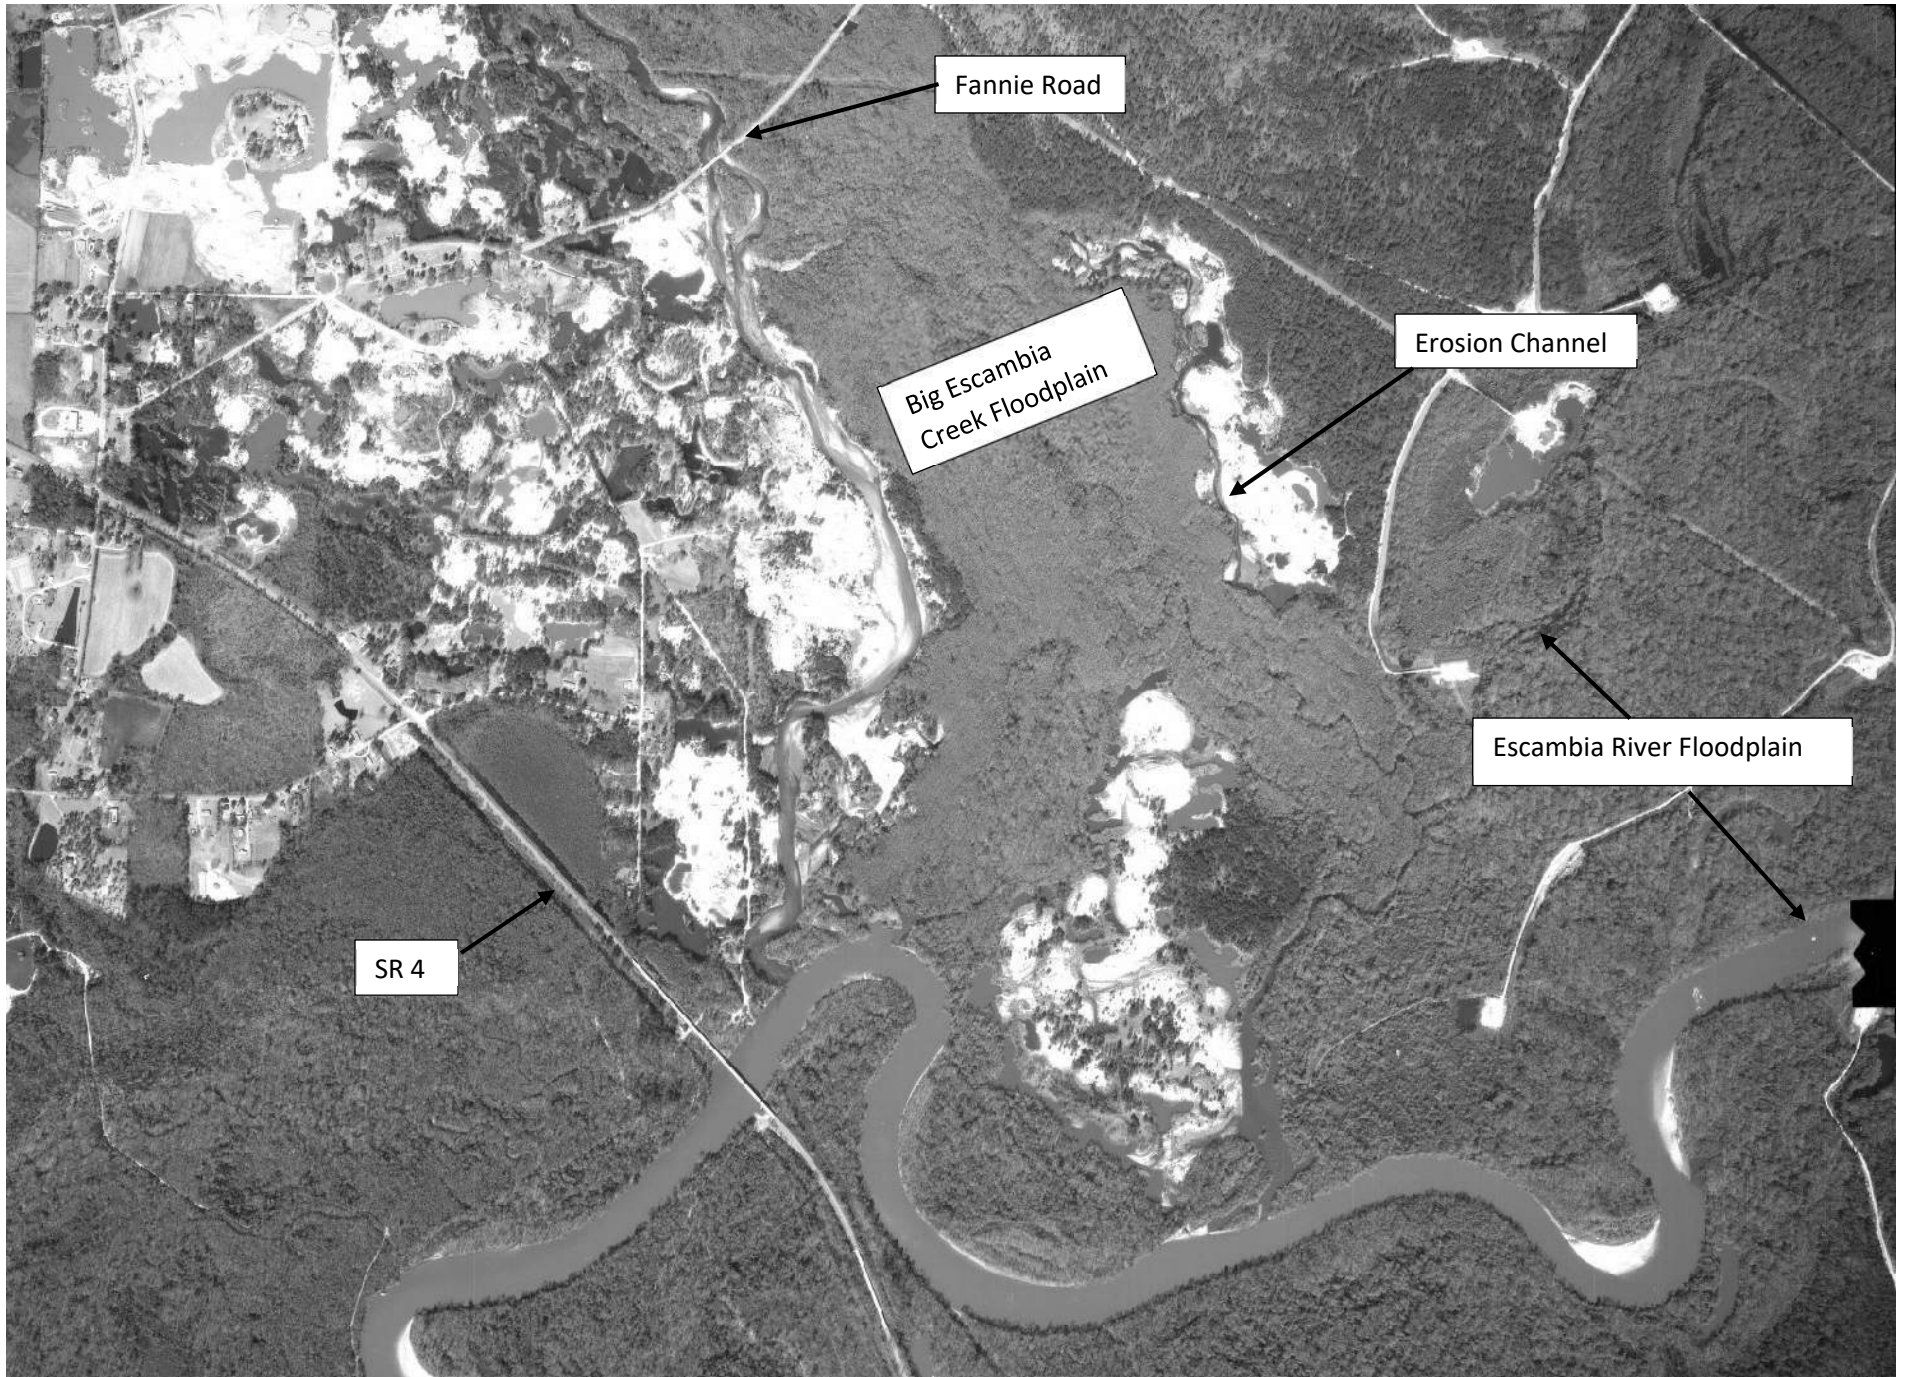
1988 Aerial Photograph

The 1988 aerial photograph is similar to previous years. The width of the Escambia River and Big Escambia Creek floodplains and their shared flows are indicated on the aerial. The north side of the Escambia River floodplain has numerous areas of standing water that represent possible oxbows or sloughs that capture and retain water due to the high groundwater table.

The east sand mine has a breach that has water that appears to originate within the Creek floodplain and flows through the entire sand mine area along its west side. It does appear as though the outfall from that mine reenters the lower portion of the main Creek channel and flows toward the river.

February 12, 1988: Illustrating the extent of the floodplain areas for Big Escambia Creek and Escambia River. Overland water flow in these areas during high water events.

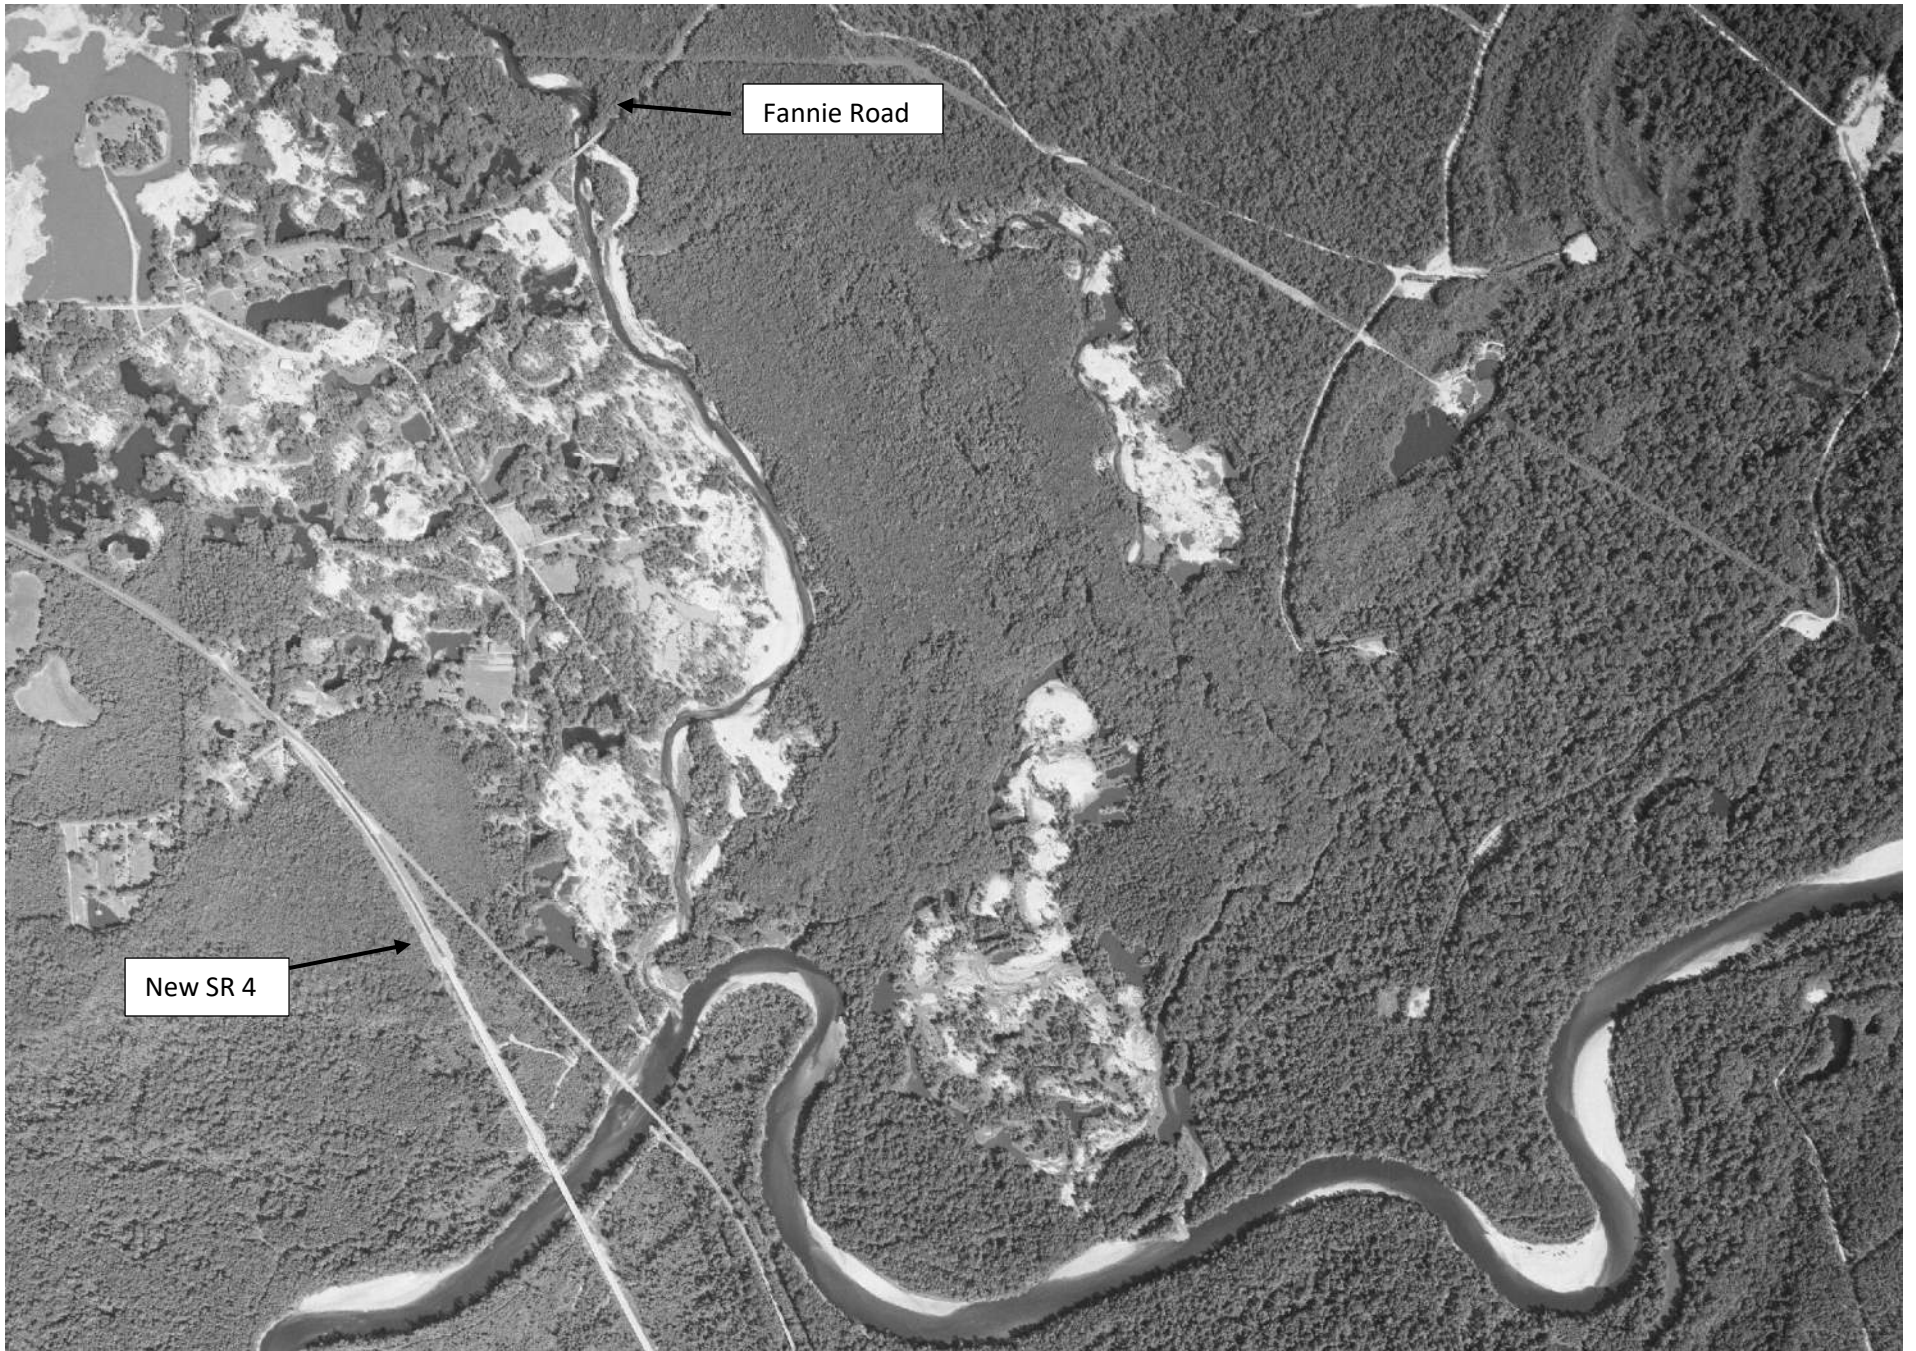
October 1, 1993: Overview of Sediment Study Area.
