Fischer Landing Town of Century Sedimentation Study June 2022

Water Resource Associates, LLC

Annotated Aerial Photography of Sedimentation Study Area - 1940 to 2019

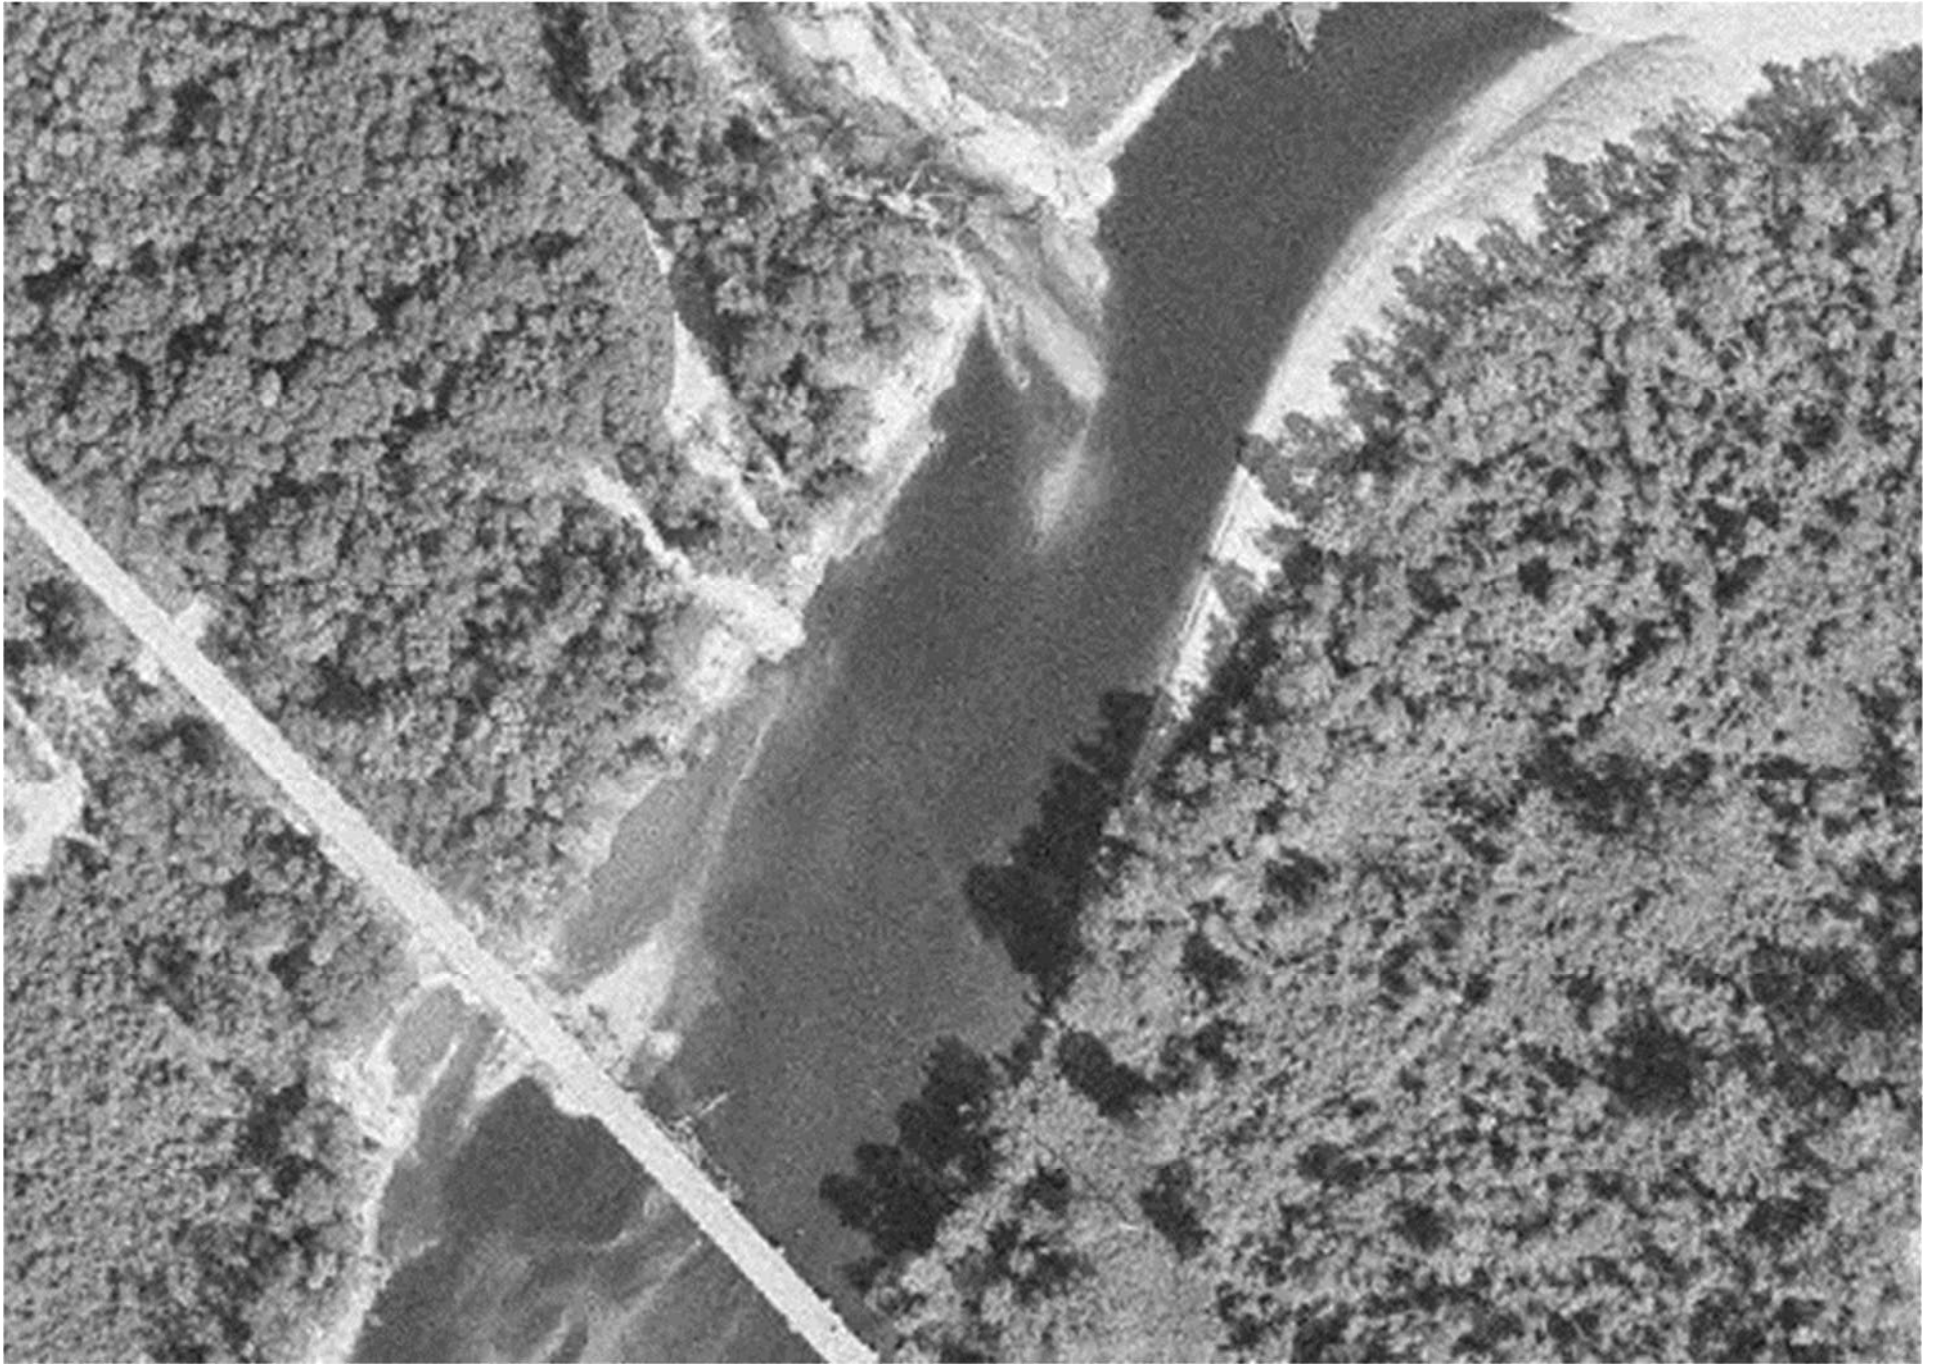
The 1993 aerials include the landscape scale of the other photographs and close-up examination of the two sand mine areas with discharges directly to the river. The erosion channel that holds the flow of Big Escambia Creek indicates strong flow through the sand mine with a large delta extending into the river against the prevailing current and moving downstream toward the SR 4 bridge. The entire area where the boat ramp will be placed is extremely shallow indicating heavy sand burden carried from the sand mine.

1993: Sand deposition out of sand mine and at old SR 4 bridge pier. Normal sand deposition is not on outside curve of river.

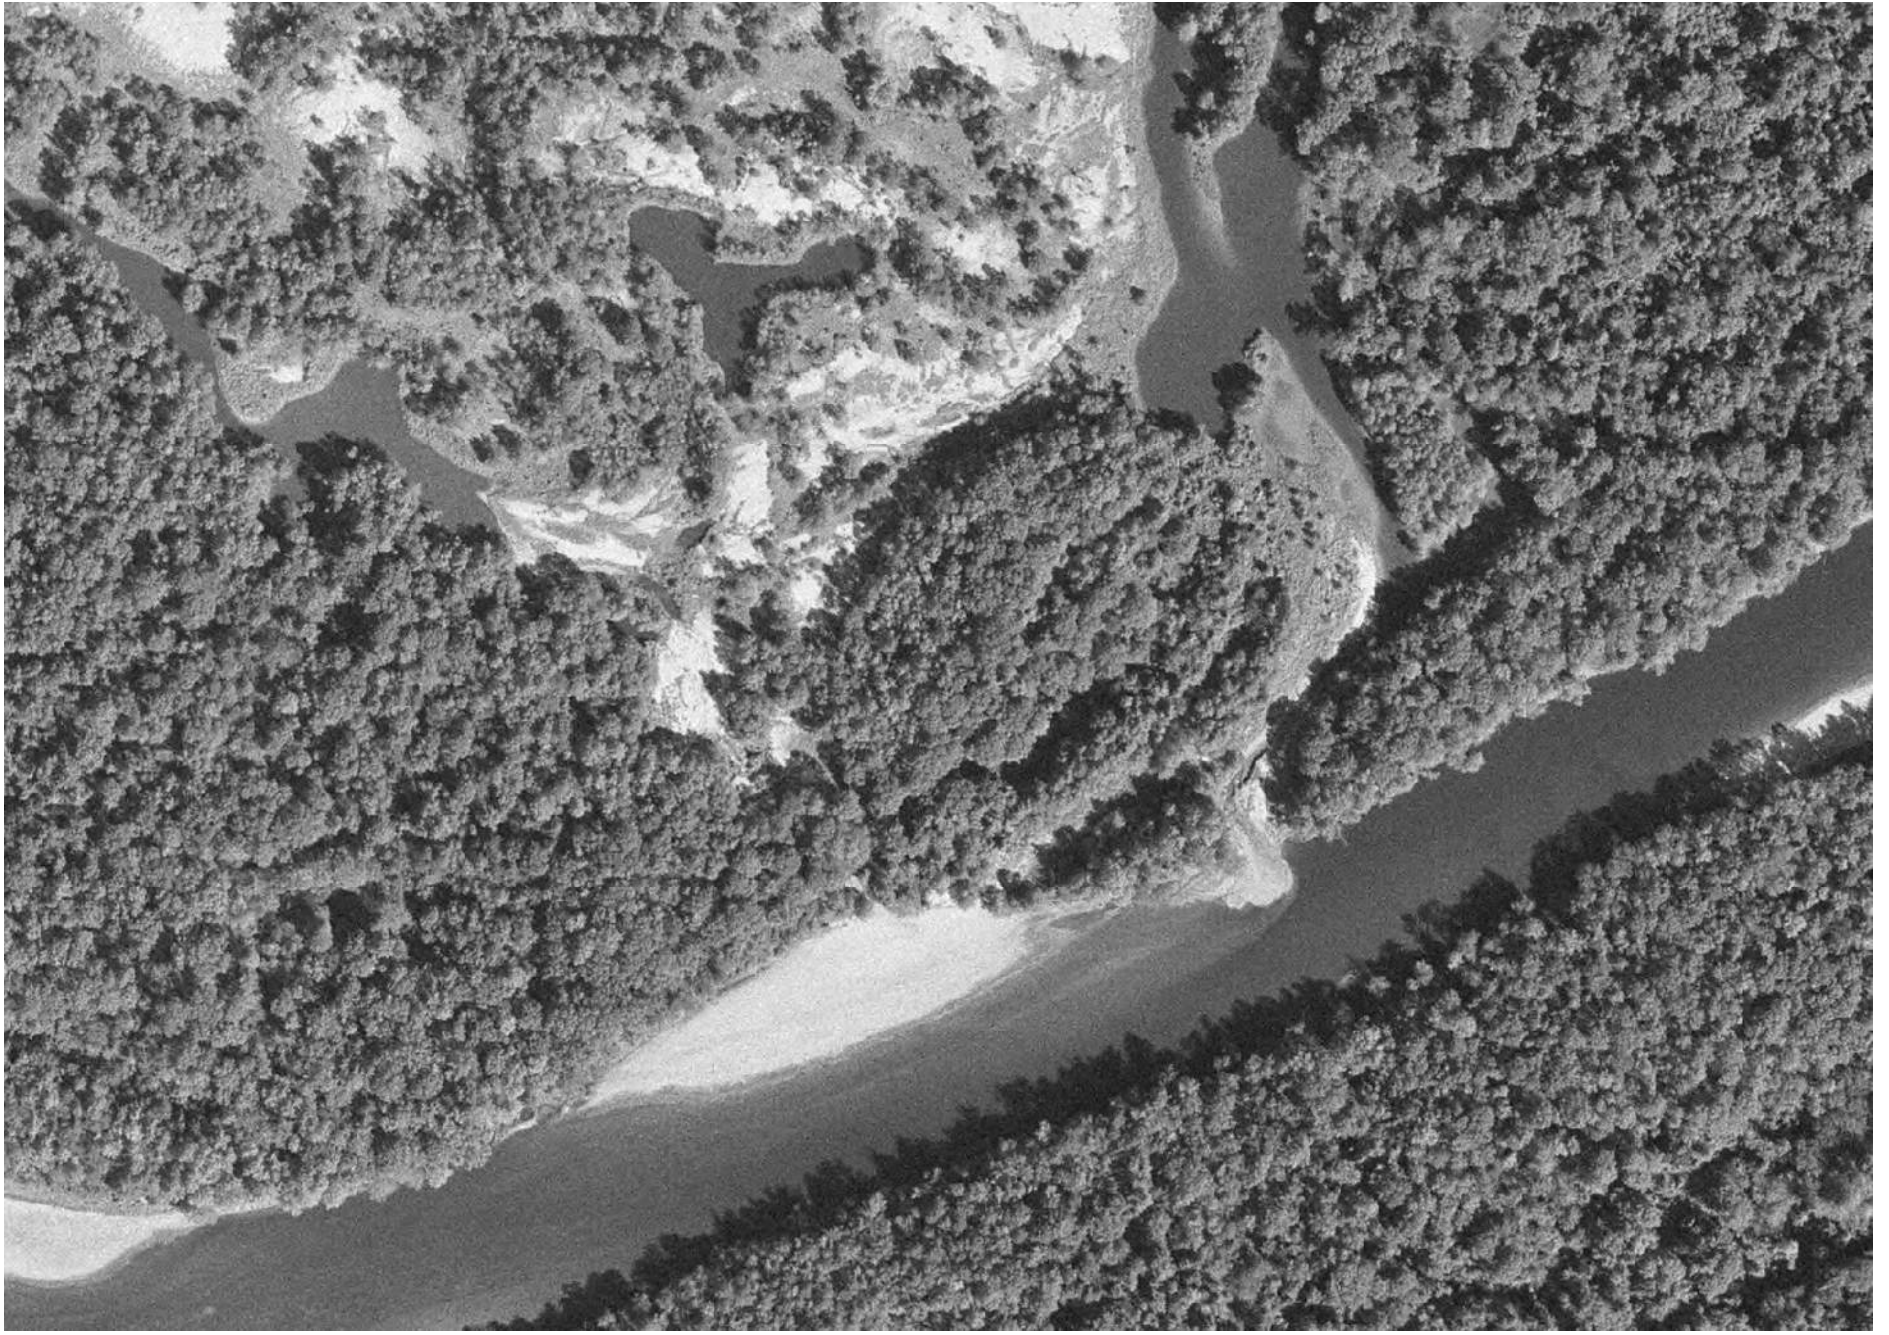
The Big Escambia Creek confluence with the Escambia River is nearly shut off with very little water entering the river. The former channel of the Creek is nearly occluded with sand from the upstream east sand mine that has built up over the years (since 1973) and become vegetated. The erosion from the east mine also appears to be flowing overland into the river just to the west of the old Creek mouth creating a sand bar along the north bank of the river.

1993: Sand deposition out of sand mine at Big Escambia Creek confluence. Note areas previously with open water are silted in. Very small outfall. Sand washing overland to deposit downstream of old channel.

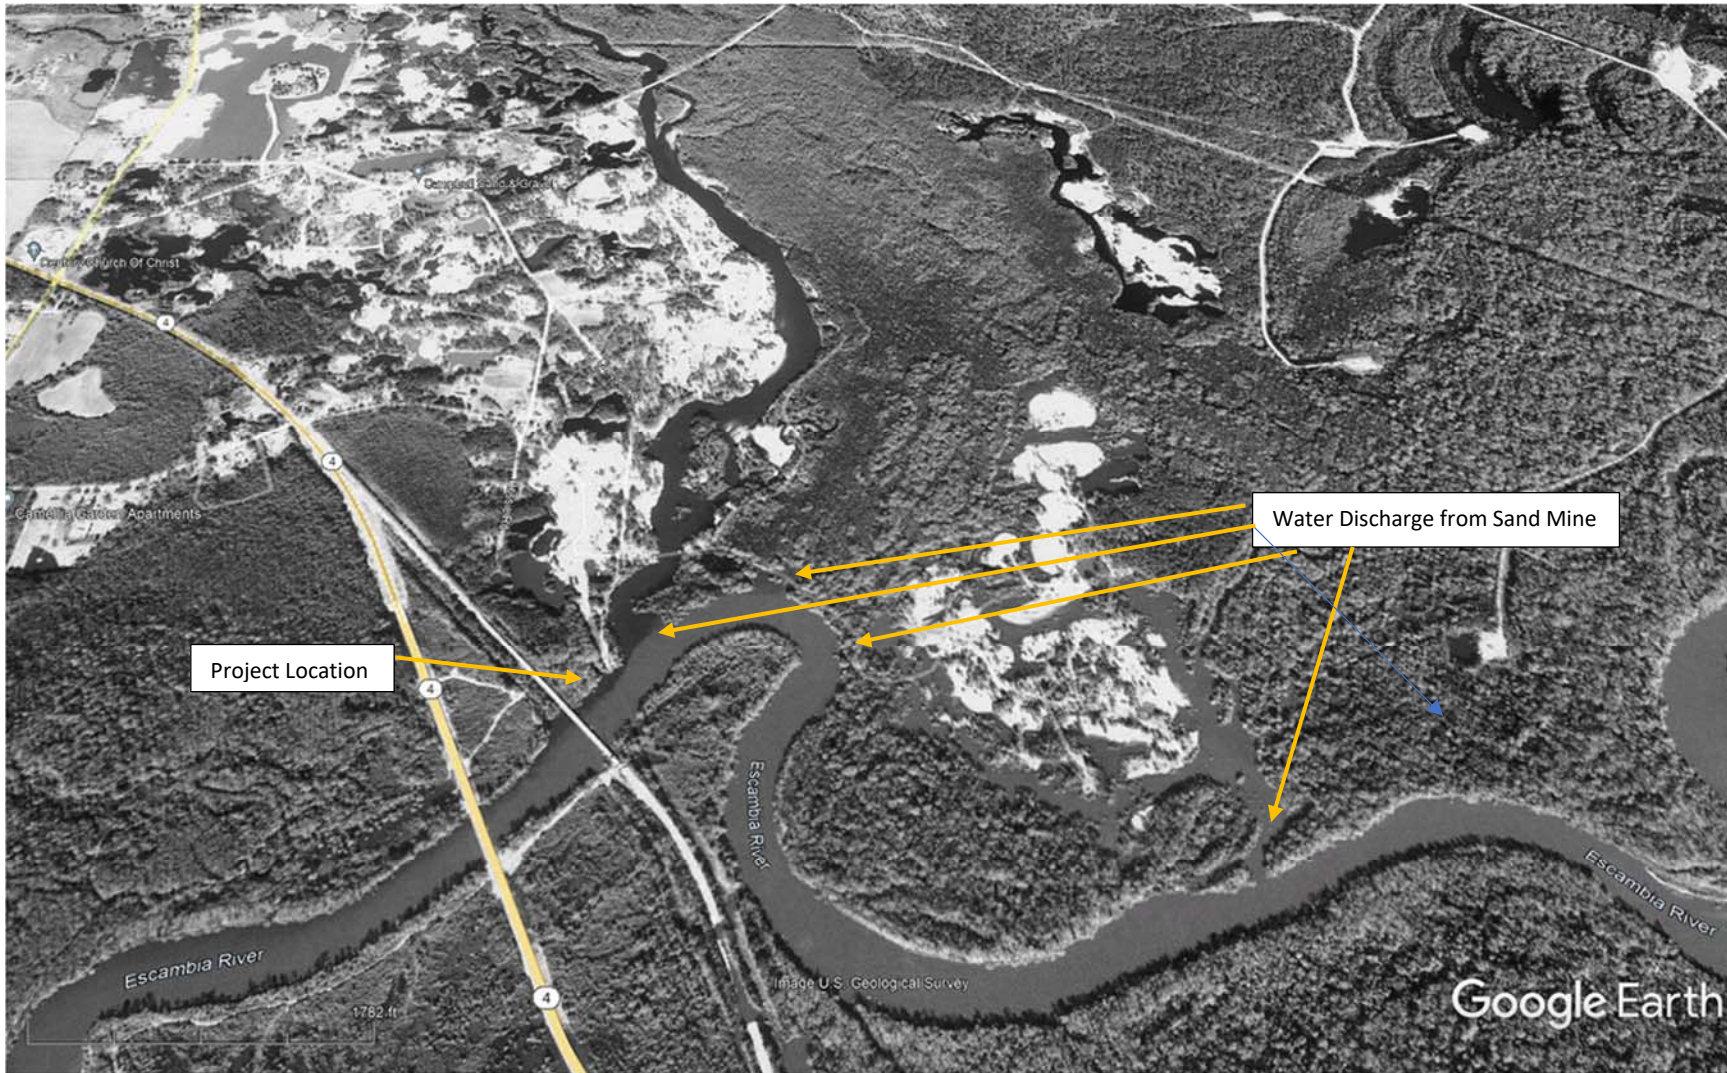
1994 Aerial Photograph

January 1994: High water event. Sand mine to the east is flooded. Erosion Channel is flowing clear, with dark flow entering river and remaining on west side. Does not fully mix until past SR 4 bridge.

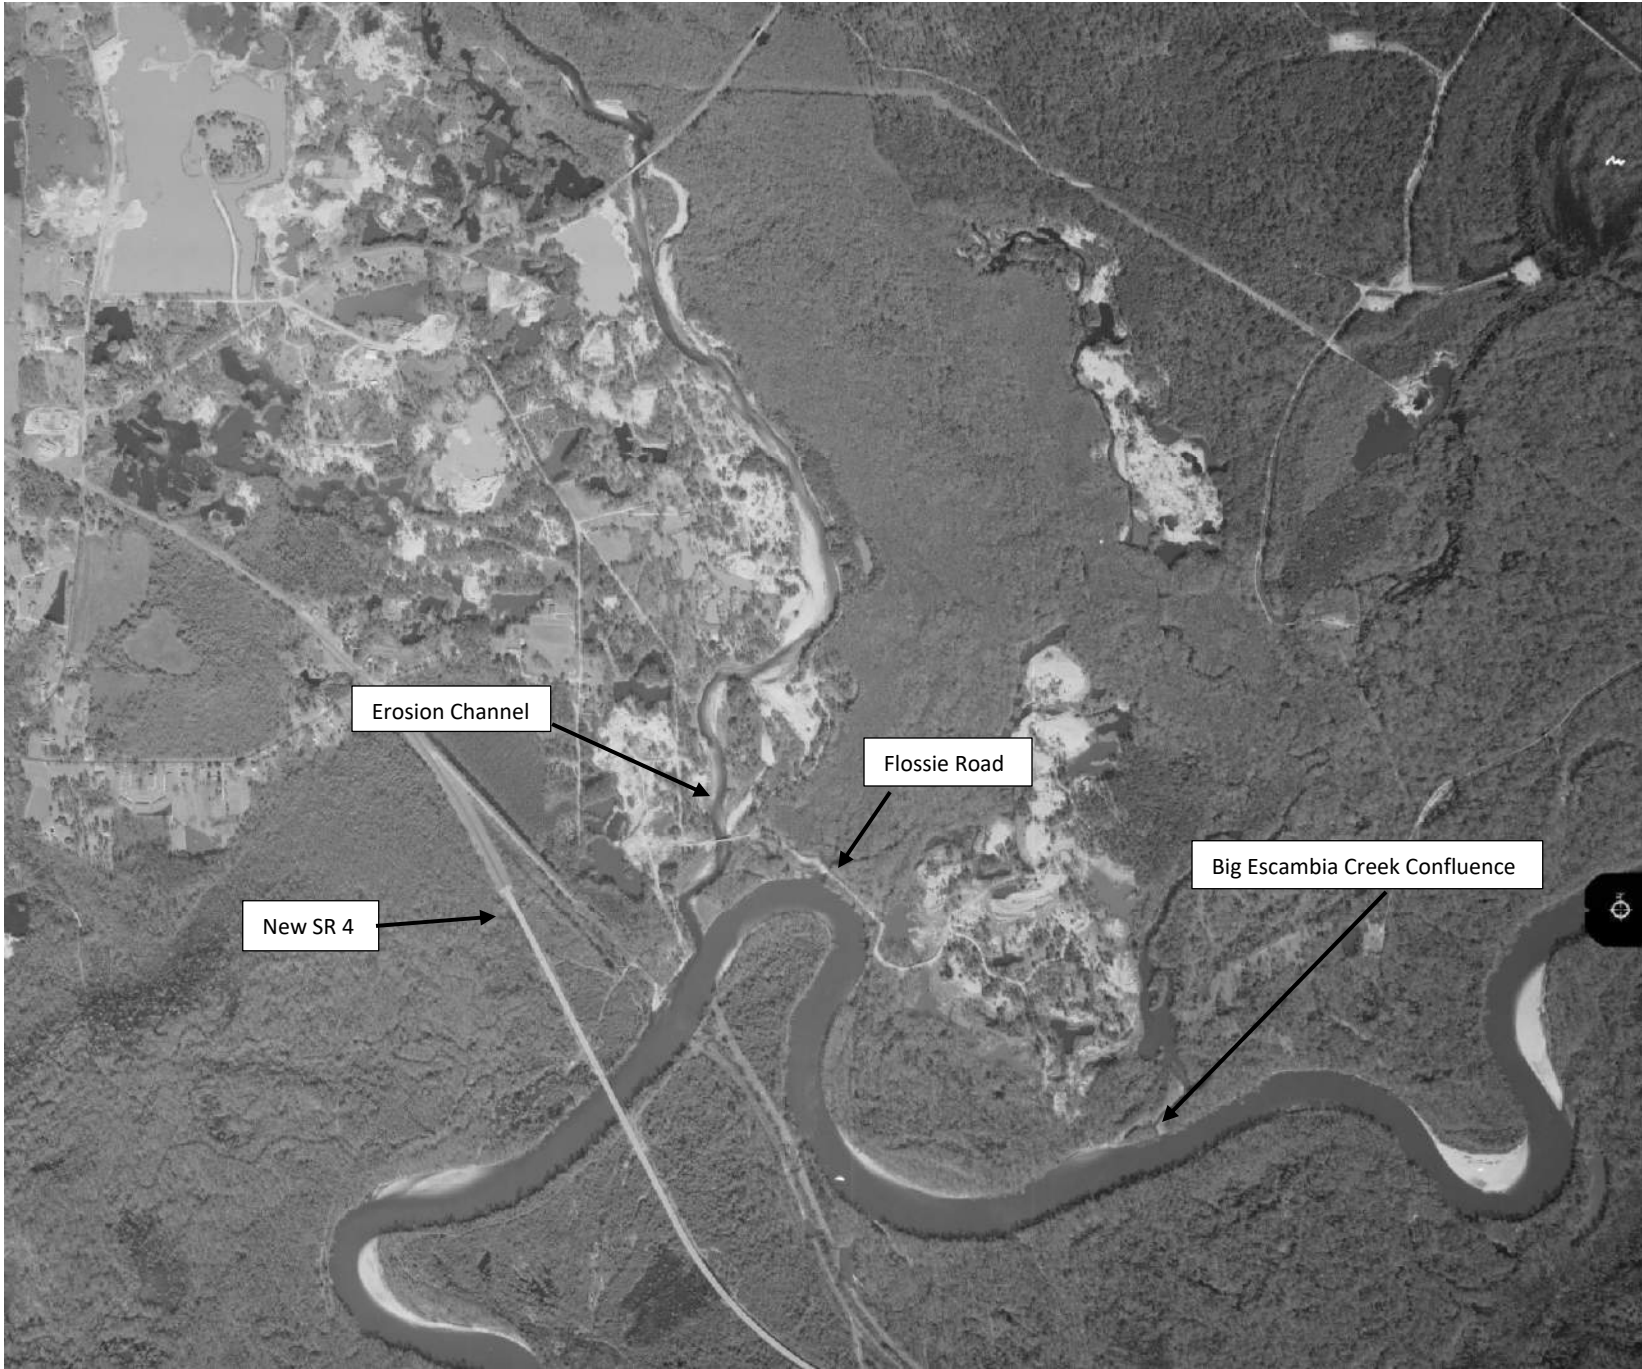
Flossie Road was built between 1994 and 1997 and it provides a direct connection over the Creek floodplain to the eastern sand mine area. The roadway crosses over two separate inflows to the Escambia River. The western bridge is over the erosion channel through the west sand mine area. The eastern bridge is over a breach in the river bank at the northernmost part of the bend in the river. The breach appears to have resulted from water buildup during

February 11, 1997: SR 4 New Alignment completed. Old bridge pilings remain in River. Flossie Road providing access to eastern sand mine area.

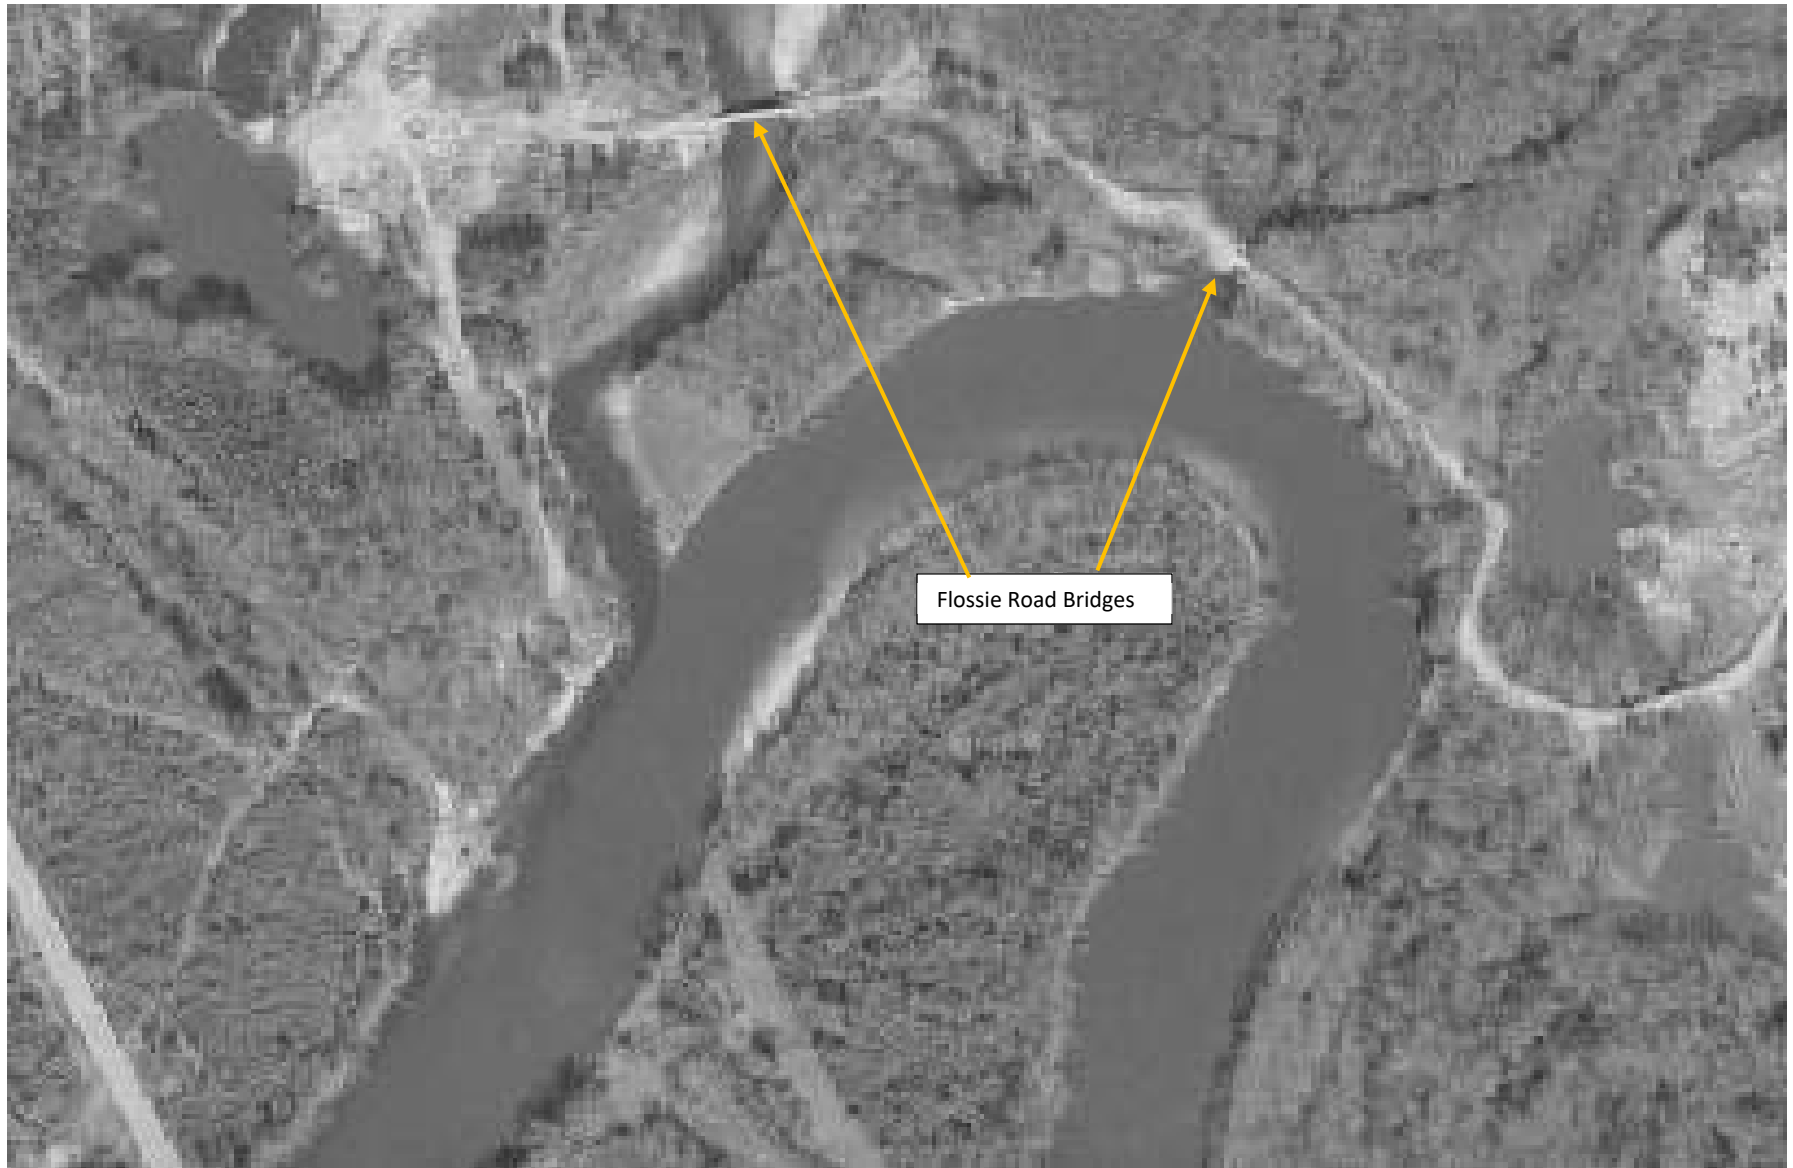
February 11, 1997: Closeup on Fischer Landing location. River shade indicates high suspended solids. Note low Suspended solids discharging from erosion channel (dark water along west bank) to the old bridge pier rubble on west bank. This is a high water event since sand bar on east bank is not visible. Flossie Road bridge was recently constructed. Provides direct access to eastern sand mine near mouth of Big Escambia Creek.

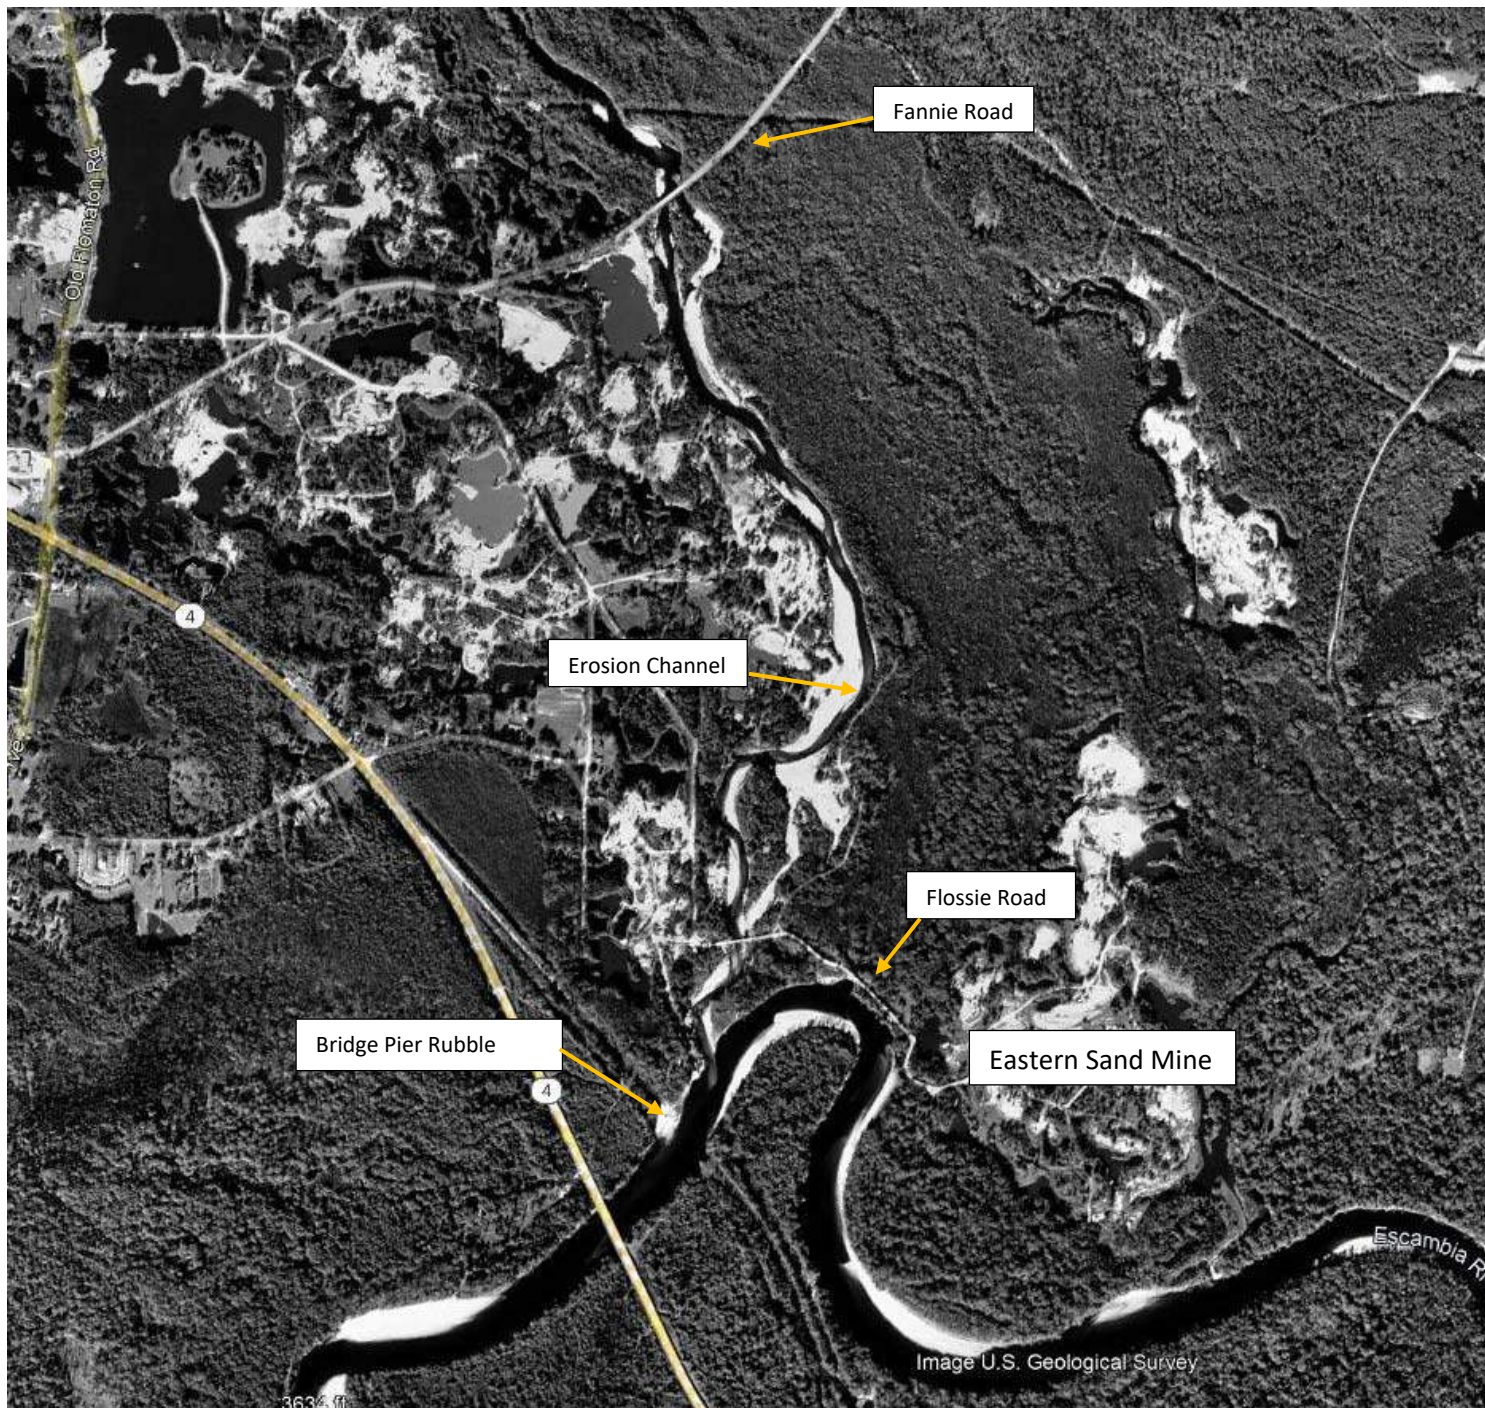
The 1999 aerial photograph shows that the eastern sand mine area operations have diminished or stopped. Vegetation is growing in with the former mouth of Big Escambia Creek nearly shut. A white reflective surface at the mouth indicates that sand is still being deposited there. The sand mine erosion channel through the west sand mine near the Project is still carrying sand into the River. The low water shows the shadow of a sand bar jutting into the mainstem river flow. Sand is being deposited at the old bridge pier rubble pile. The channel below Flossie Road is nearly filled with sand deposits.

November 1999: Eastern sand mine area is more overgrown with former downstream erosion areas becoming vegetated.

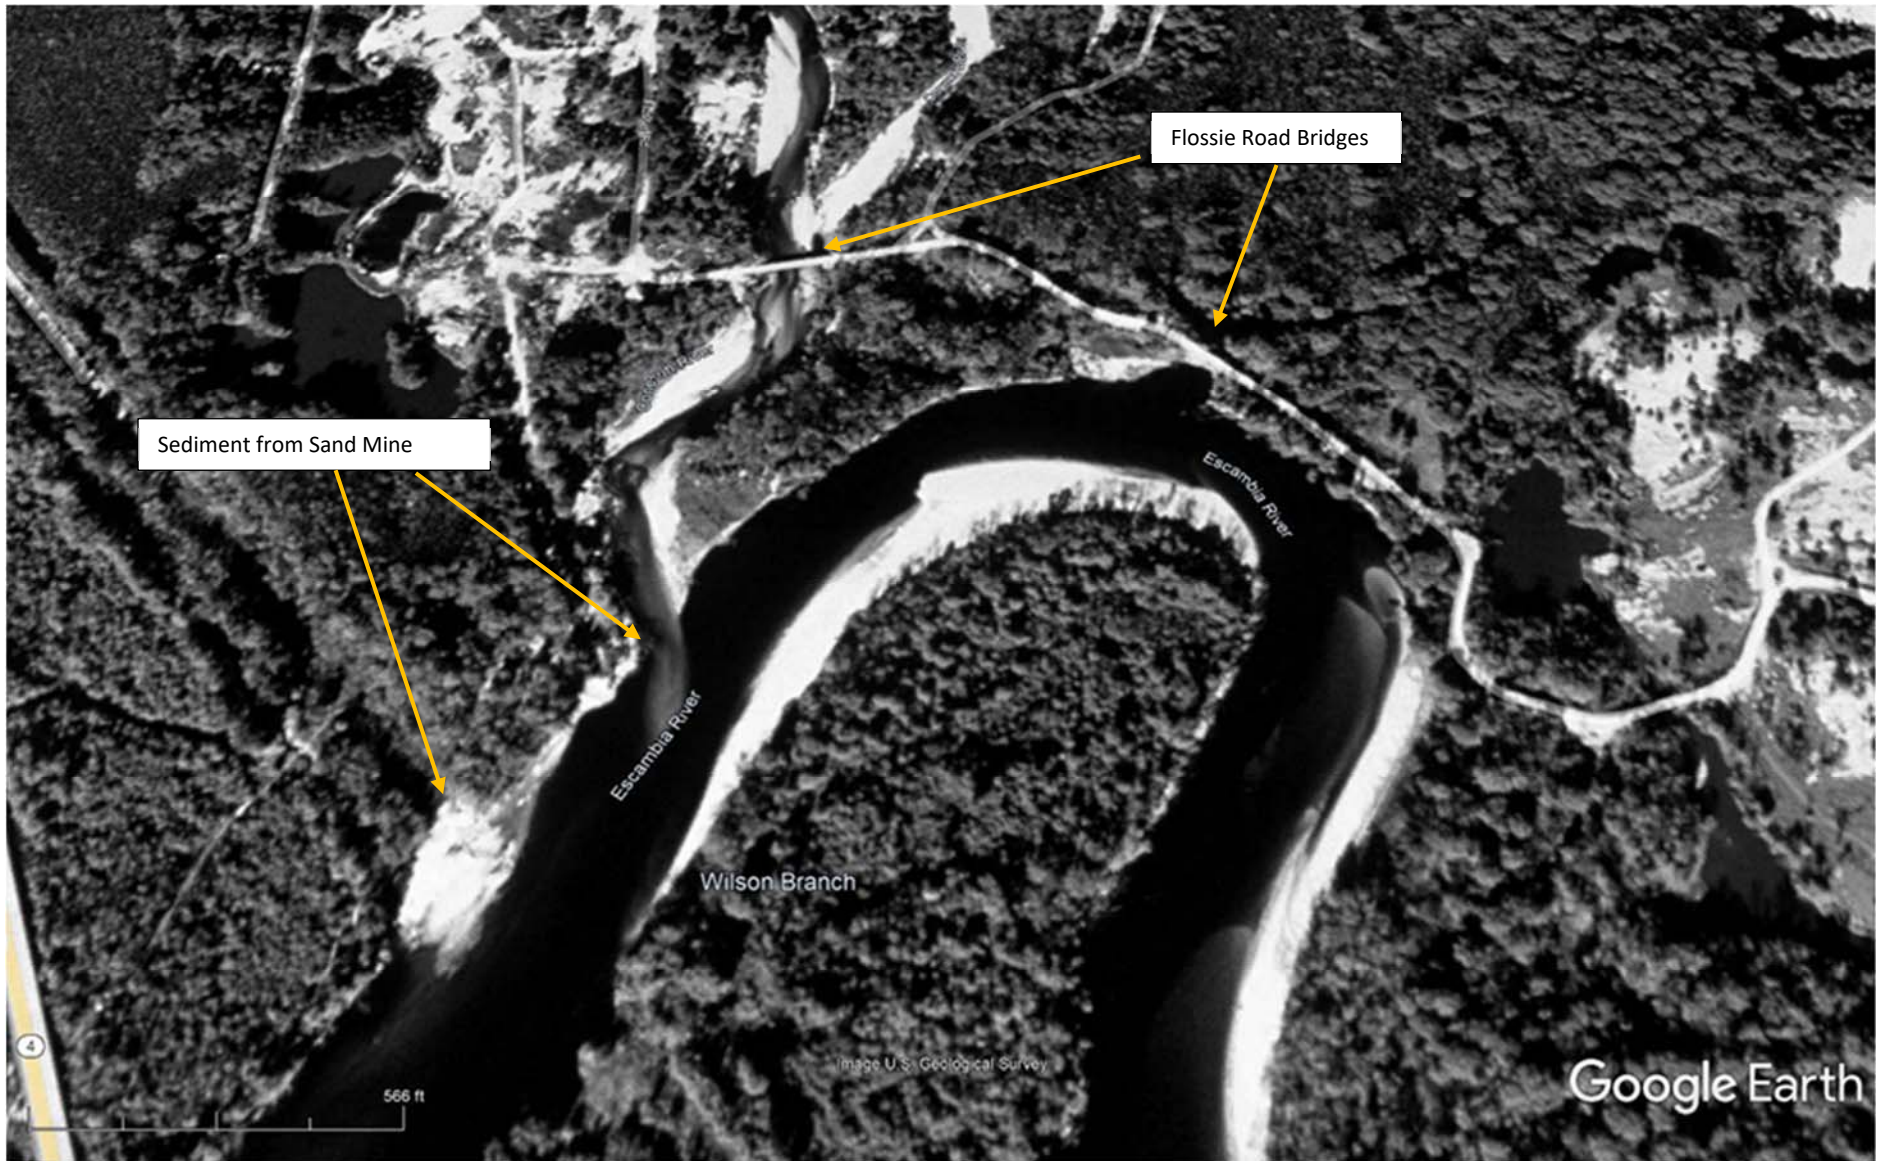
November 1999: Closeup of Fischer Landing location. Sand from western mine location has created a sub-surface sand bar at the outfall location. Sand buildup in the vicinity (upstream and downstream) of the bridge pier rubble indicate that the structure has some effect on the deposition of sediment load.

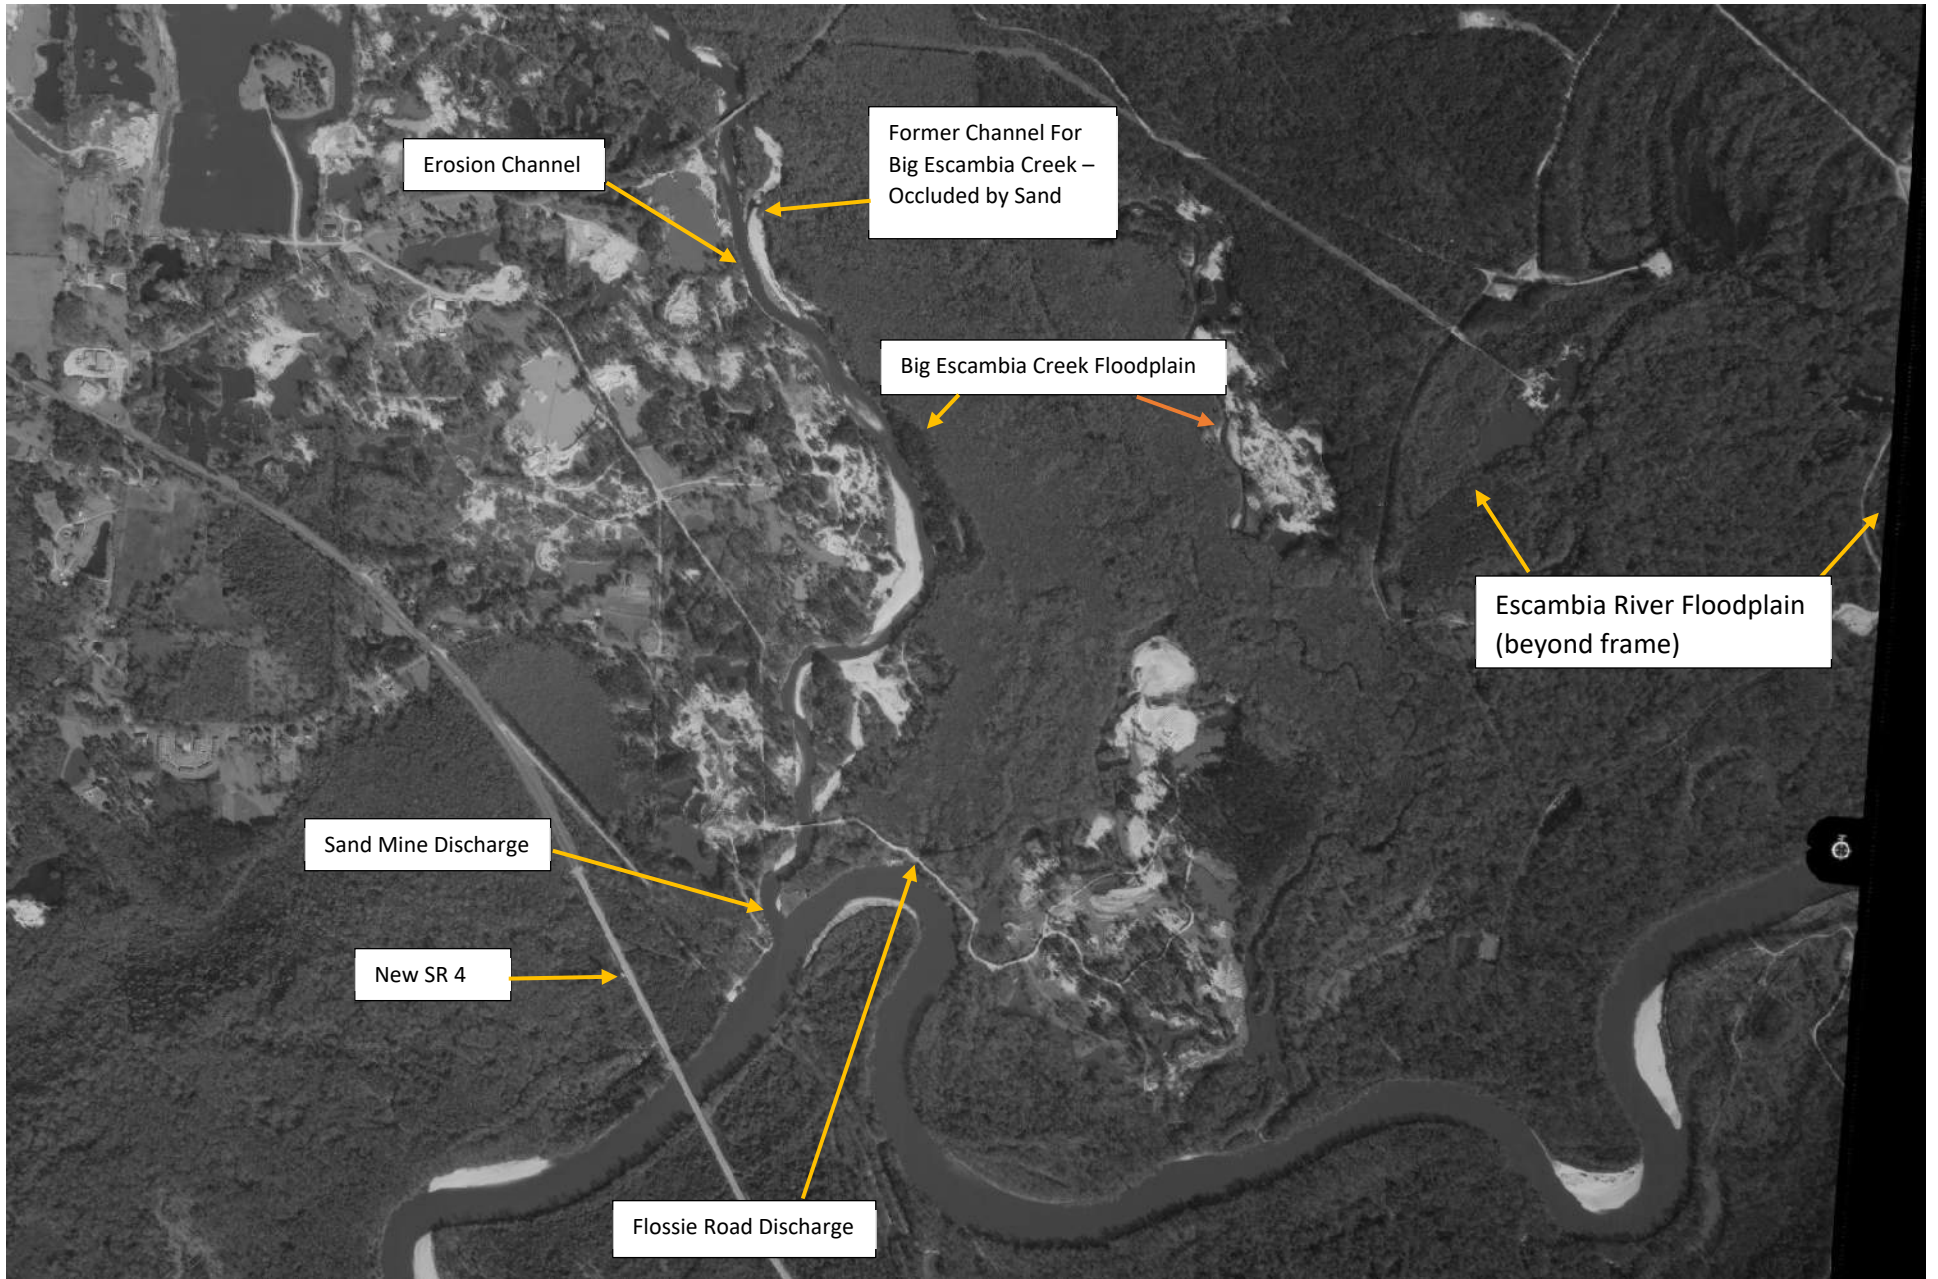
2000 Aerial Photograph

A 2000 aerial clearly indicates that the old channel is no longer functional from Fannie Road to the confluence with the Escambia River. The opening at the Creek confluence with the Escambia River is greatly diminished from the 1978 aerial photograph. The opening remained, possibly due to water flowing out of the east sand mine adjacent to the Creek channel that was breached in previous years. It should also be noted, however, that the floodplain for Big Escambia Creek appears to extend from the sand mine channel south of Fannie Road to a point at Flossie Road where the river bank has breached. Flossie Road was built in 1997 with two bridges. The western bridge is over the erosion channel, the eastern bridge is over a breach in the river bank that drains from the creek floodplain between the two existing mine locations.

February 15, 2000

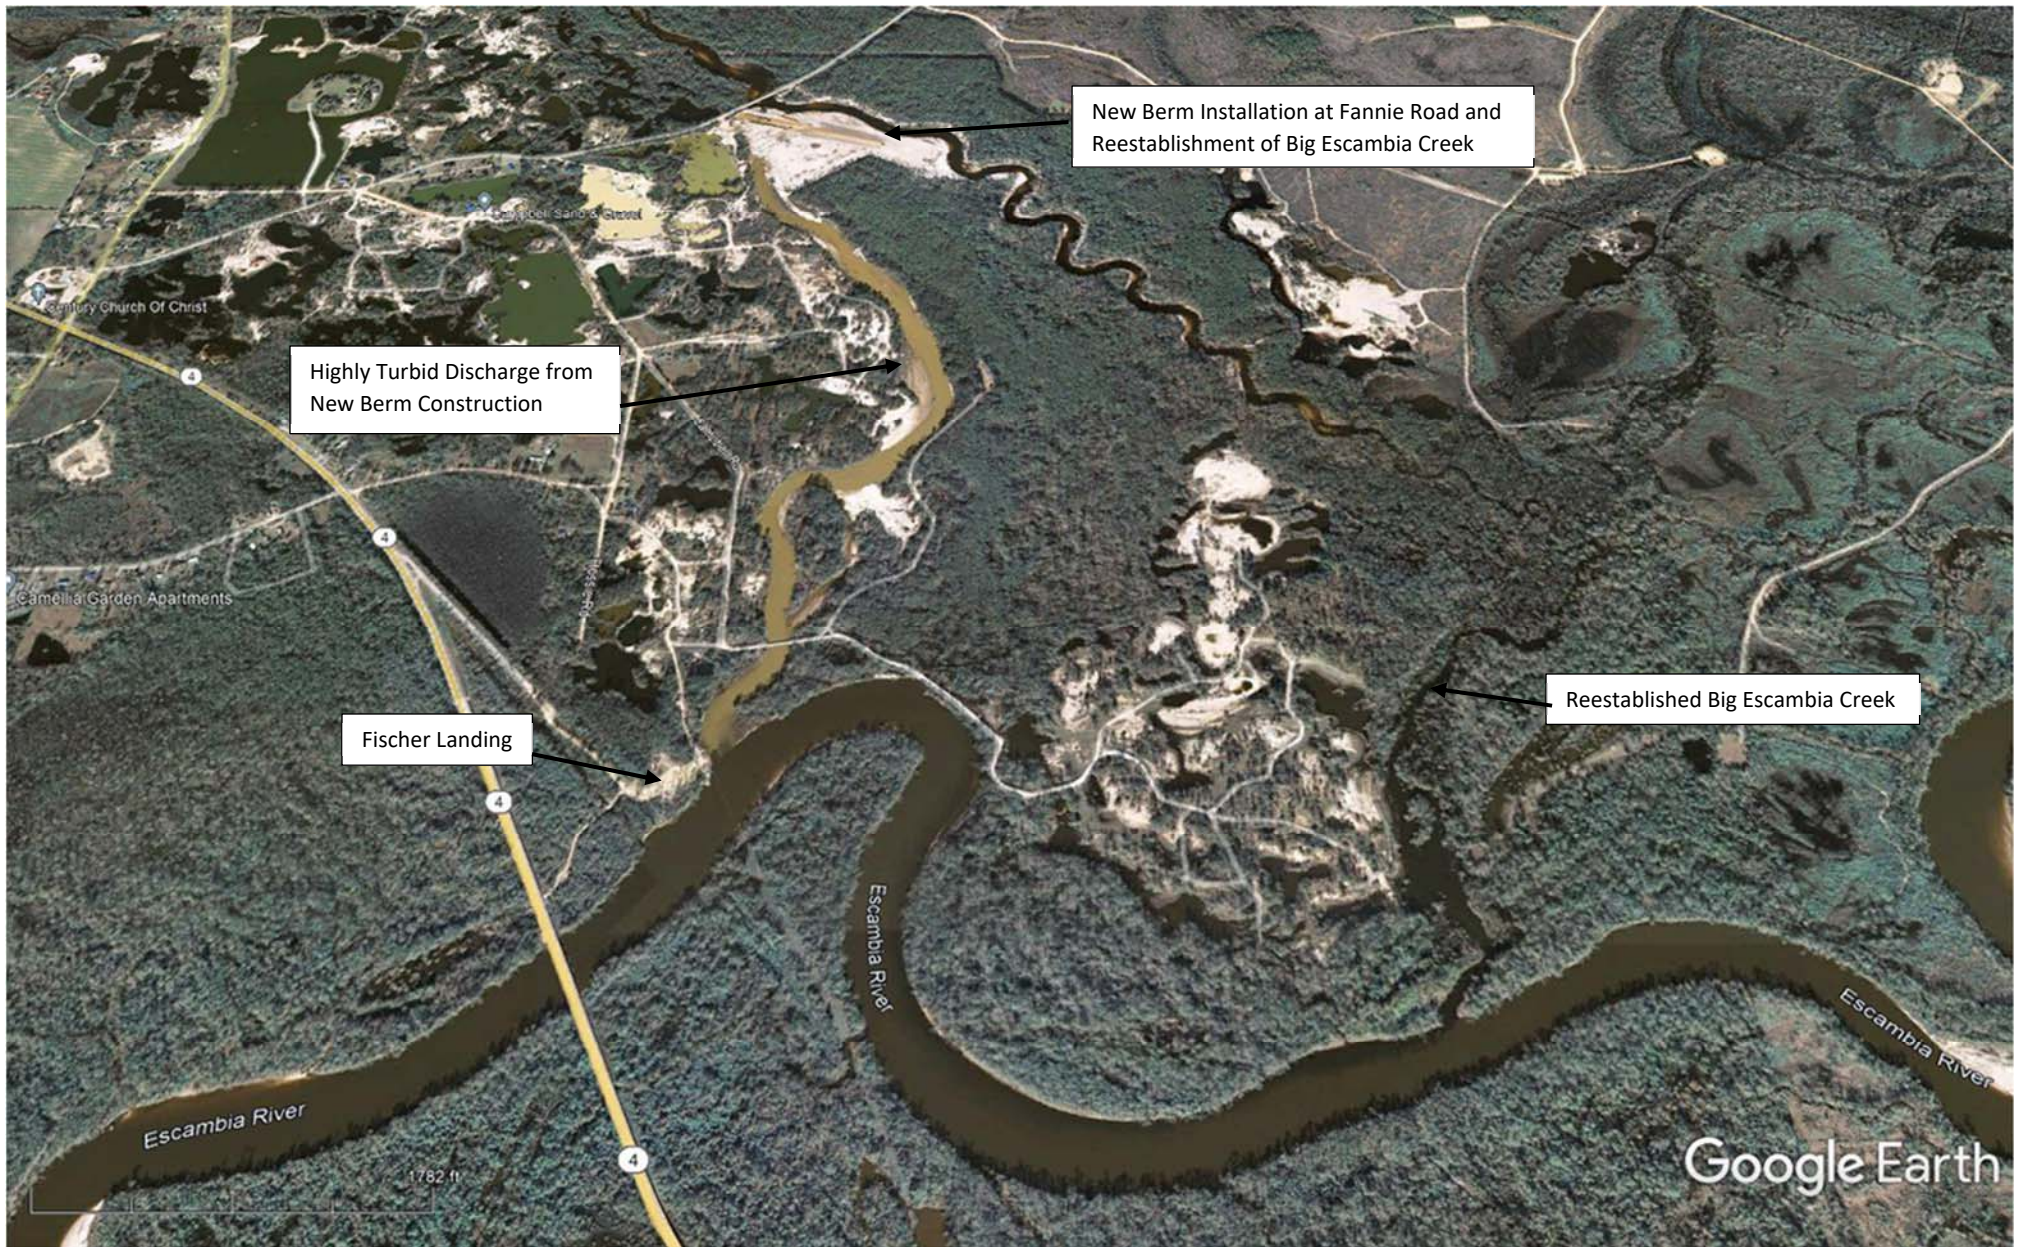
2004 Aerial Photograph

Between 2000 and 2004 work on the Fannie Road bridge included the construction of a large berm and the reestablishment of Big Escambia Creek into its former Channel. The 2004 aerial photograph shows the new Fischer Landing with the old boat ramp in use. The erosion channel in the western sand mine is highly turbid, which is in contrast to the river which has a much lower load of suspended solids.

It also appears that the east side of the eastern sand mine has a newly built berm separating it from the Creek. The creek is running clearer and the discharge into the river is reestablished.

December 2004: First aerial with Fischer Landing in place. Old Boat Ramp. Berm at Fannie Road has reestablished Big Escambia Creek.
