Fischer Landing Town of Century Sedimentation Study June 2022

Water Resource Associates, LLC

Annotated Aerial Photography of Sedimentation Study Area - 1940 to 2019

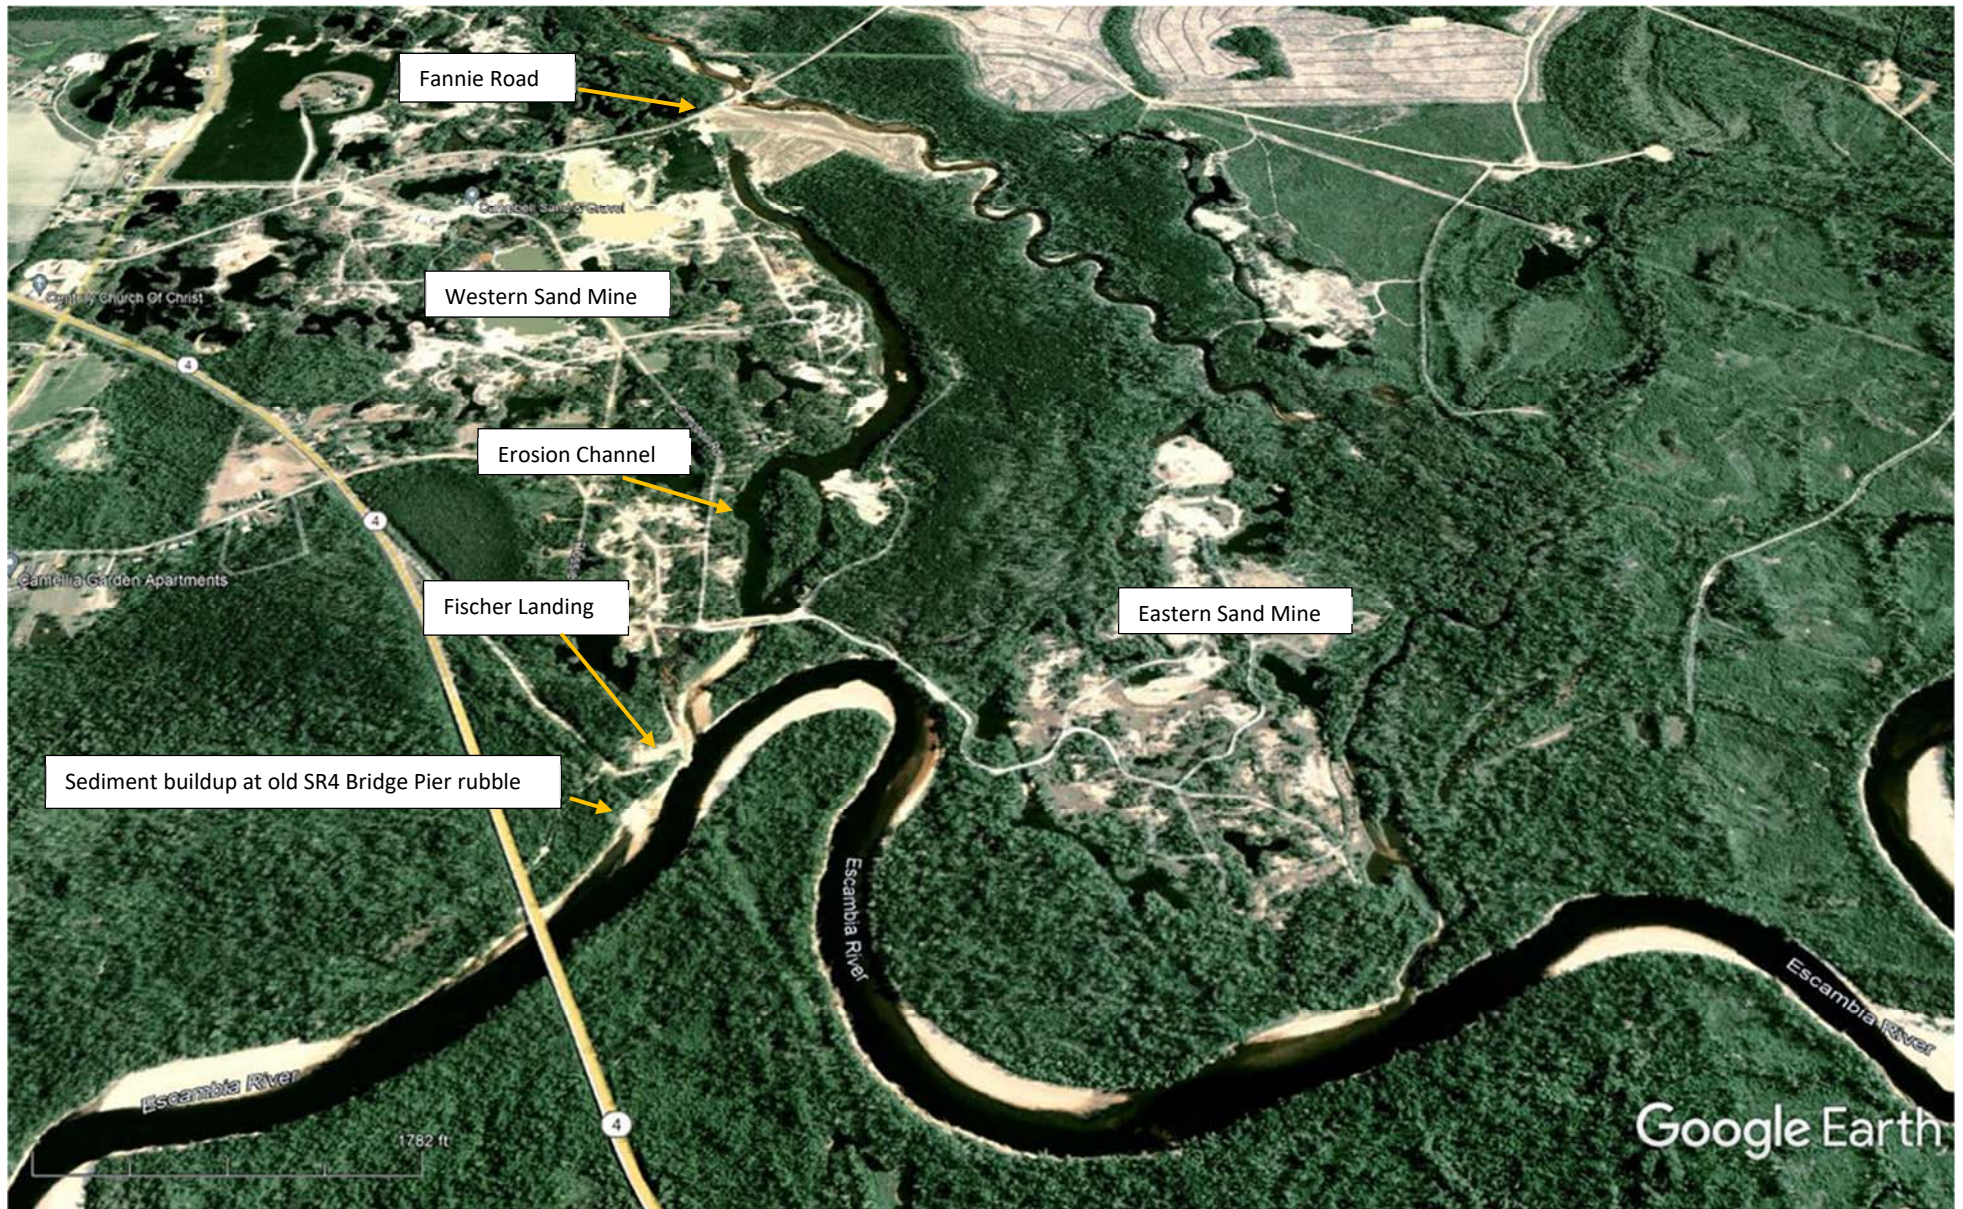
The 2006 aerial is a low water period where the normal sand bar locations are visible. Additionally, the erosion channel is filled with sand to near occlusion. Sand has entered the river and formed a large sand bar that is located at Fischer Landing. The old SR 4 bridge pier rubble has formed a downstream blockage of flow that has resulted in the deposition of sand extending past the boat ramp for Fischer Landing.

June 2006: Big Escambia Creek has been restored to its historic channel. Erosion channel in western sand mine remains. Sand mine areas to east and west have regained vegetation indicating reduced or halted operations. Sediment is still an issue downstream of the erosion channel. Fischer Landing is impacted. Big Escambia Creek no longer flows through eastern mine area.

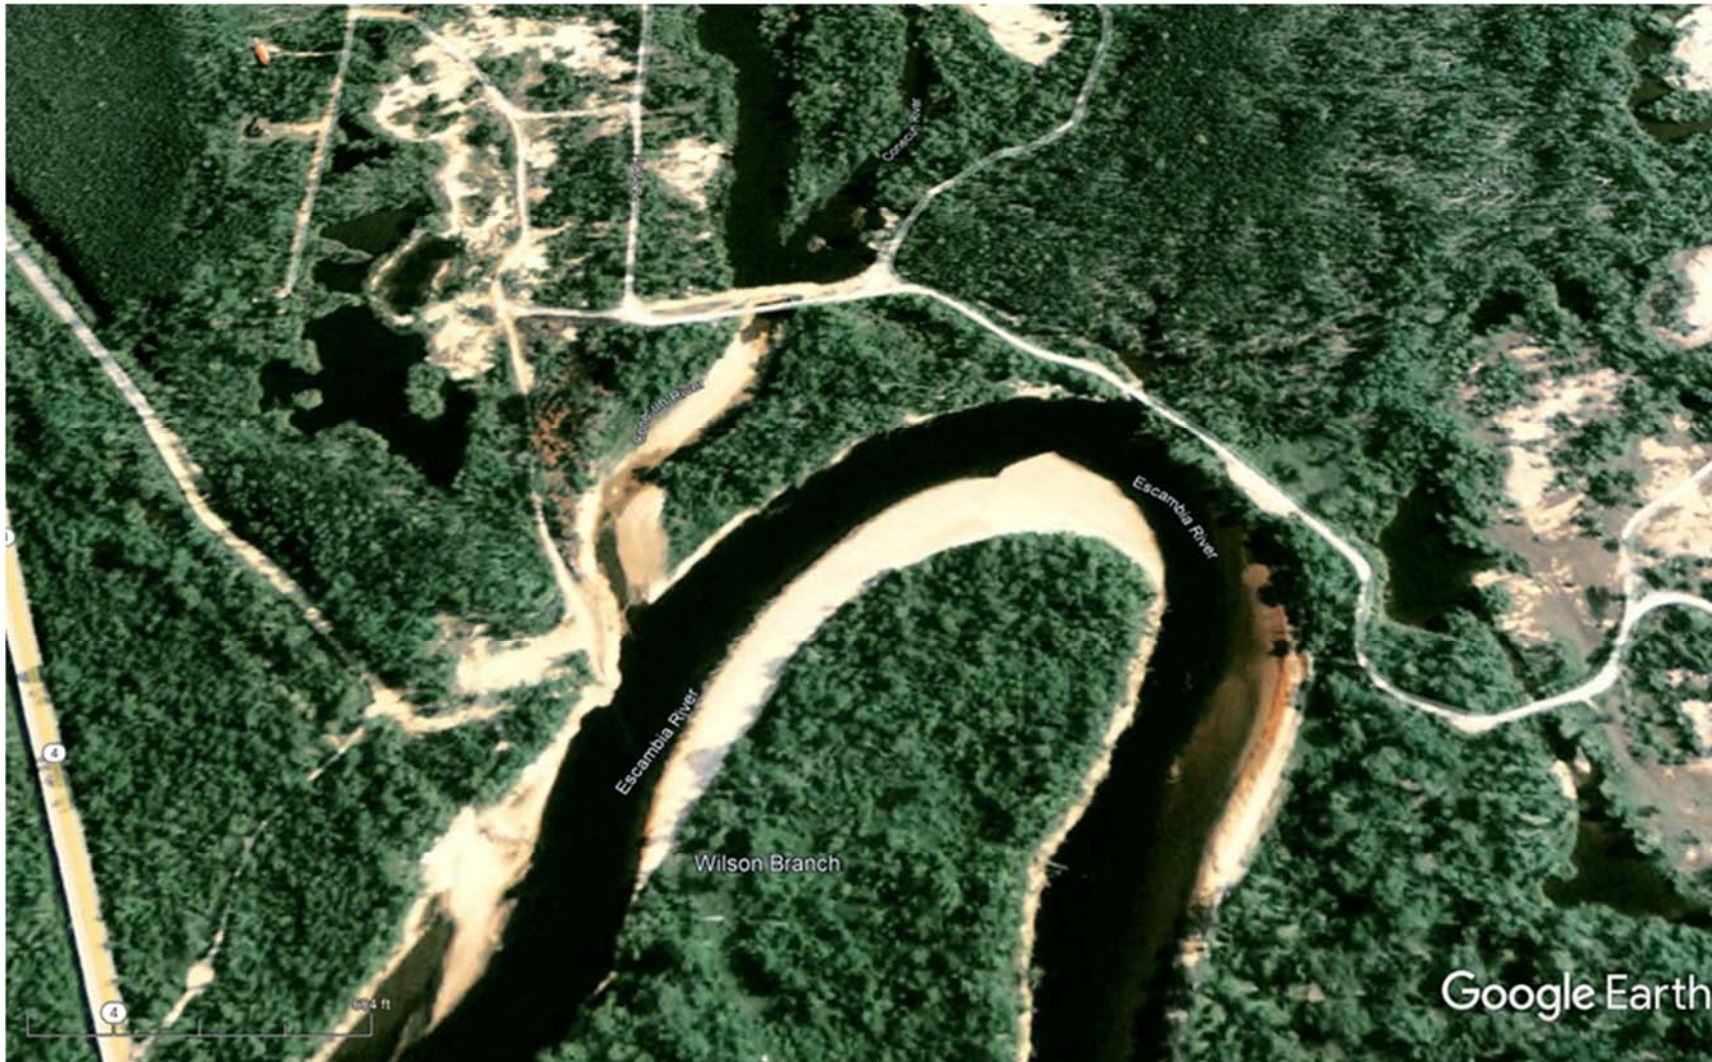
Both Flossie Road Bridges have been modified from previous conditions to block direct sand deposition into the river. In the closeup, the western bridge has an upstream dam that extends across the entire opening. The sand downstream of the dam is extensive. In this low water period, the standing sand nearly occludes the flow out of the sand mine area. The eastern bridge also has a flow restricting dam upstream of the bridge. Both dams allow high water to overflow the dams.

June 2006: Erosion Channel has been blocked by a dam upstream of Flossie Road. A dam is also in place at the eastern Flossie Road bridge. Sediment still impacting Fischer Landing from below the new dam. Bridge pier rubble presents a location for sediment deposition to extend up river to Fischer Landing.

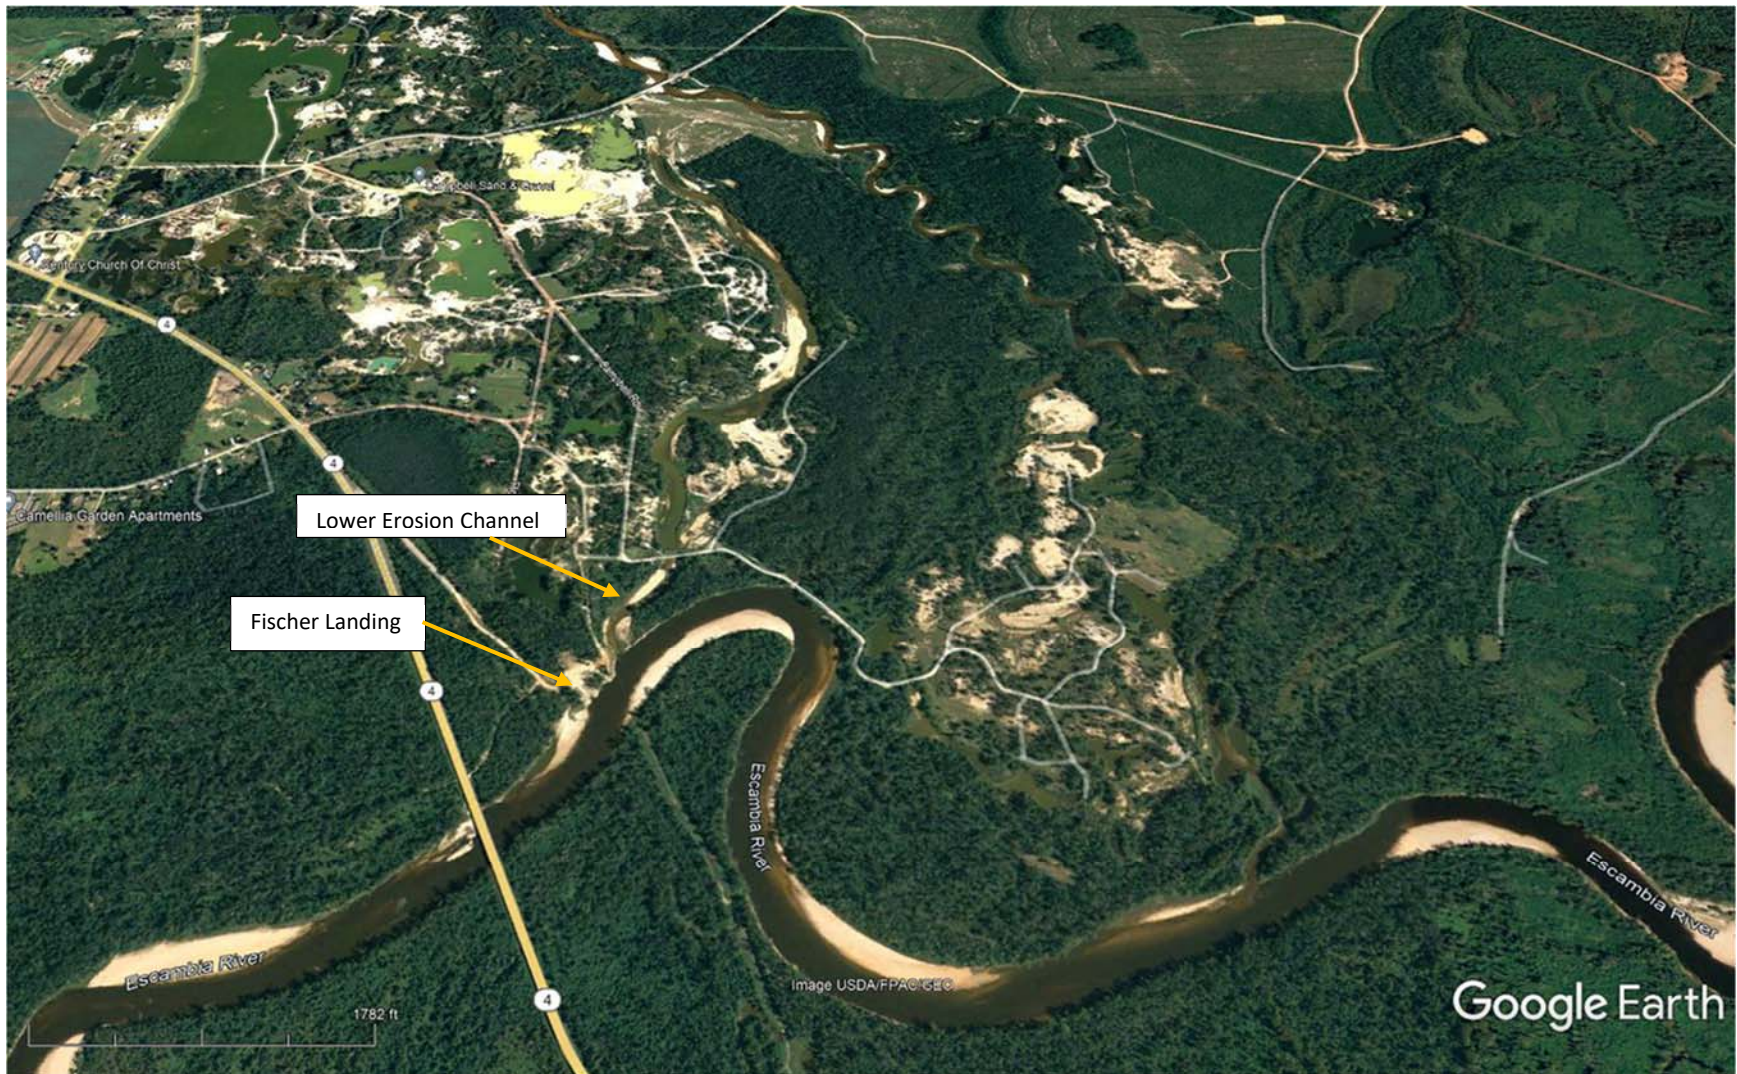
The 2007 aerial also indicates a low water period where sand has built upstream of the old SR 4 bridge pier rubble. Fischer Landing boat ramp is not physically blocked. However, the lower erosion channel still carries a sand burden into the river. The sandbar downstream of the rubble pile appears to be the result of sand from the lower erosion channel. Open water just downstream of the dam on Flossie Road would appear to indicate that high water events still move sand over the dam and into the lower erosion channel.

November 2007: Sediment from the lower portion of the Erosion Channel has accumulated at the SR 4 bridge rubble. Fischer Landing boat ramp is not blocked, but the accumulation of sediment indicates that there is an effect on currents in the area.

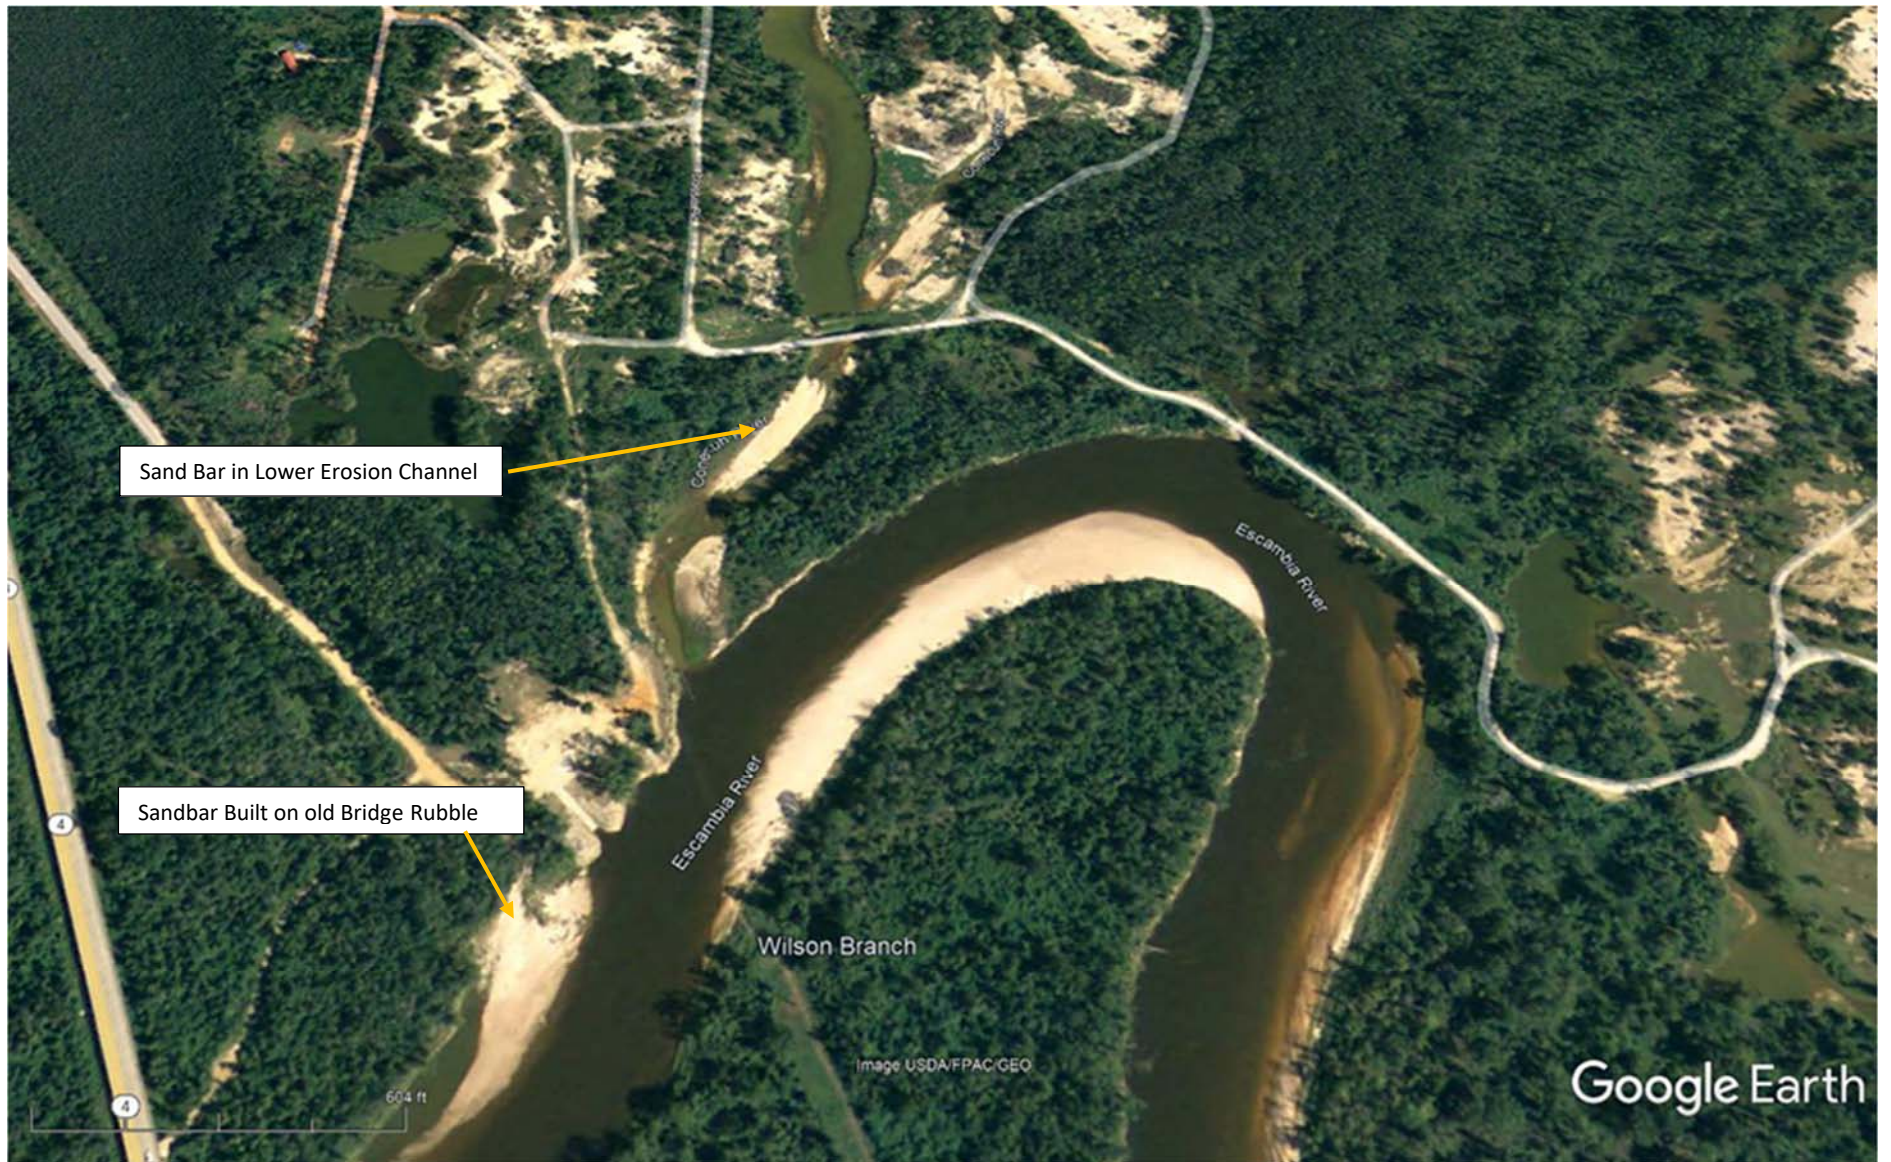
November 2007: Closeup of Fischer Landing. Sediment surrounding the old SR 4 Bridge Pier rubble. Note the open water between the Flossie Road dam and downstream. It appears to result from high water washing over the dam and depositing sand immediately upon passing over the dam.

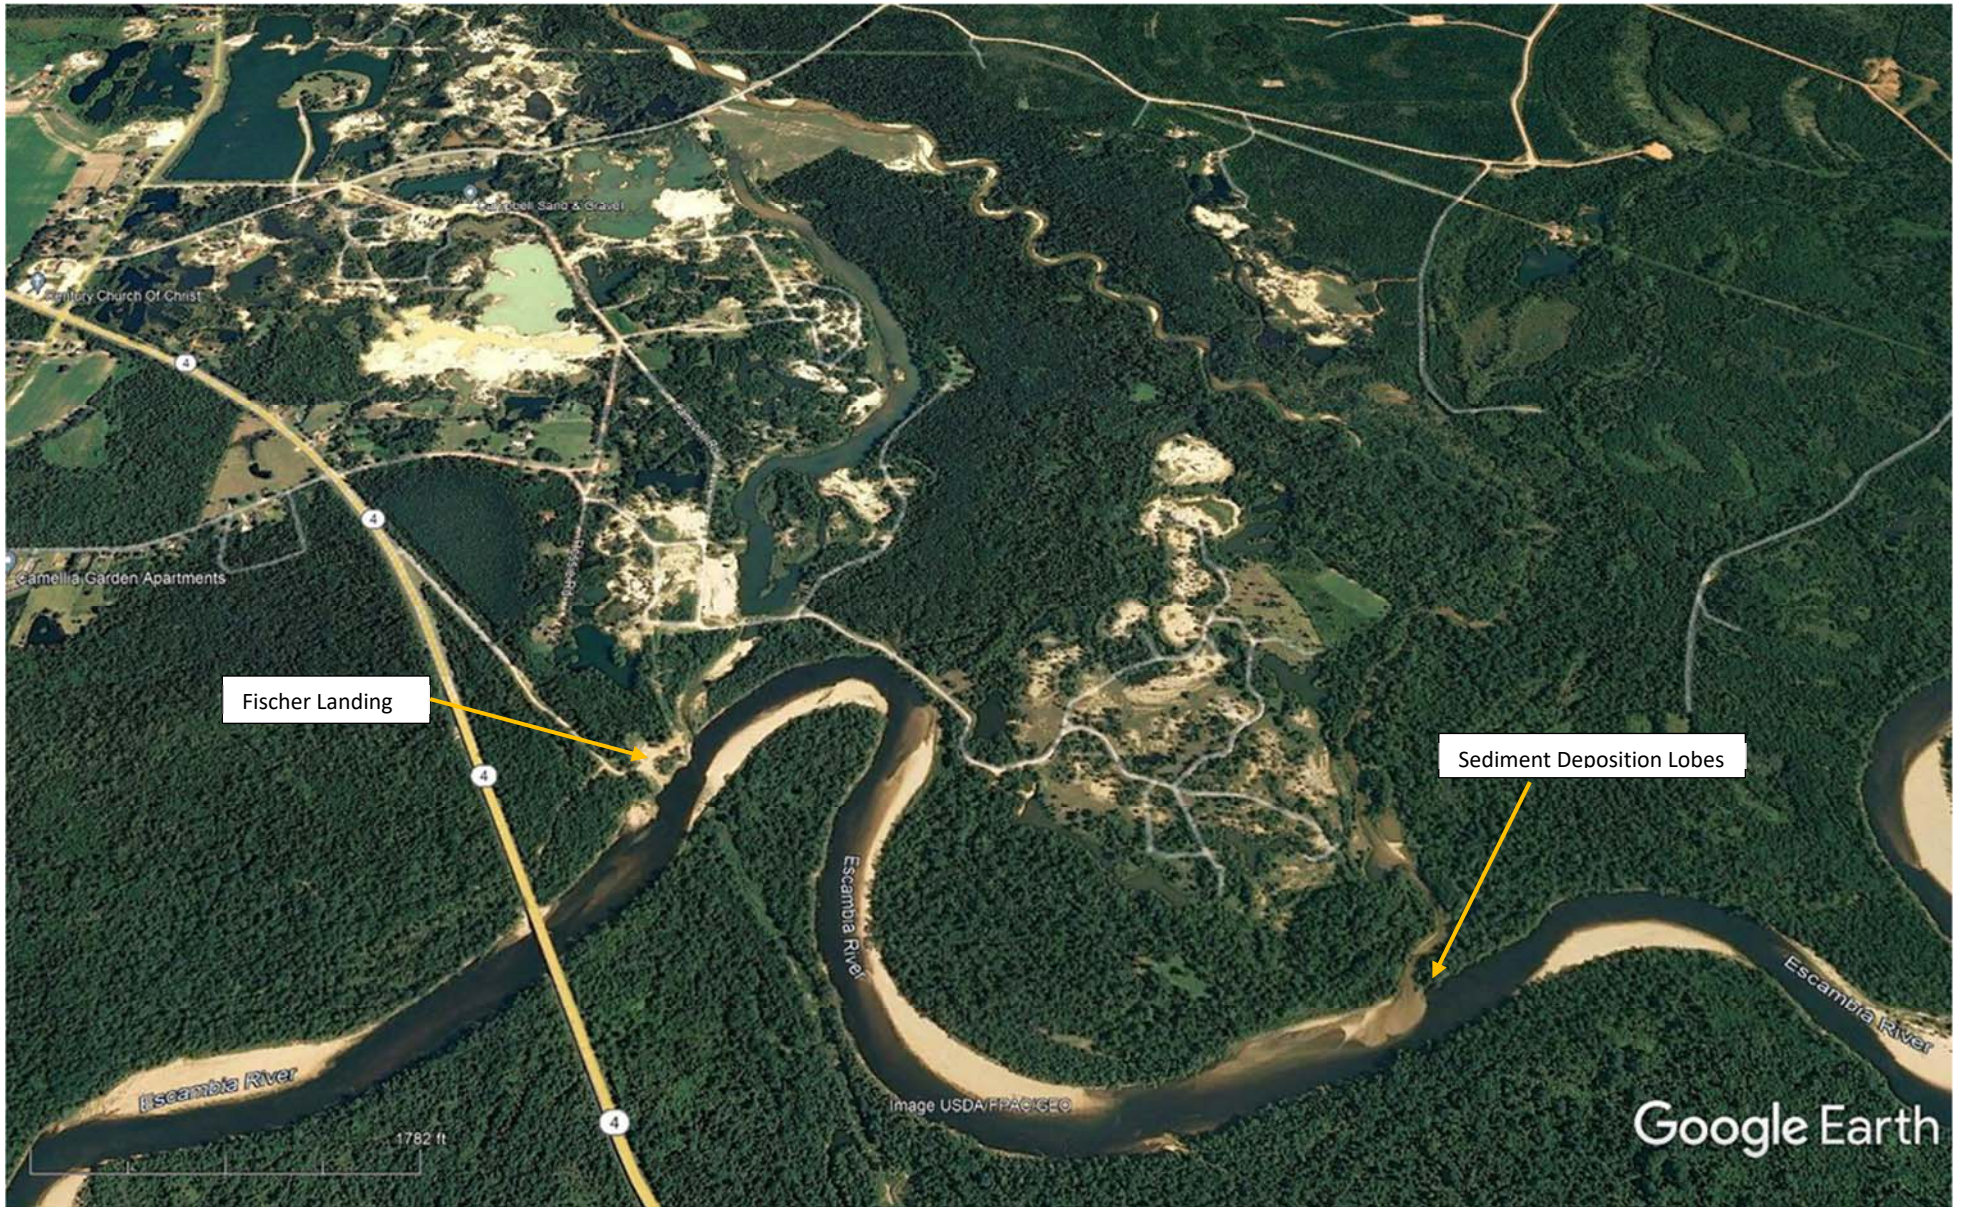
2011 Aerial Photograph

In the September 2011 aerial, there appears to be a large discharge of sediment into the Escambia River at the Creek confluence. The photograph is a low water period. A reading of the USGS river height gauge for 2011 indicates early year rains and a rain event in September, but the river height is not above eight feet during September (Flood stage is 17 feet).

September 2011: Low water period. New sediment at mouth of Big Escambia Creek. Bridge rubble also has sand deposited. No sand visible at Fischer Landing. Note length of sand bars within the River from the Creek to near Fischer Landing.

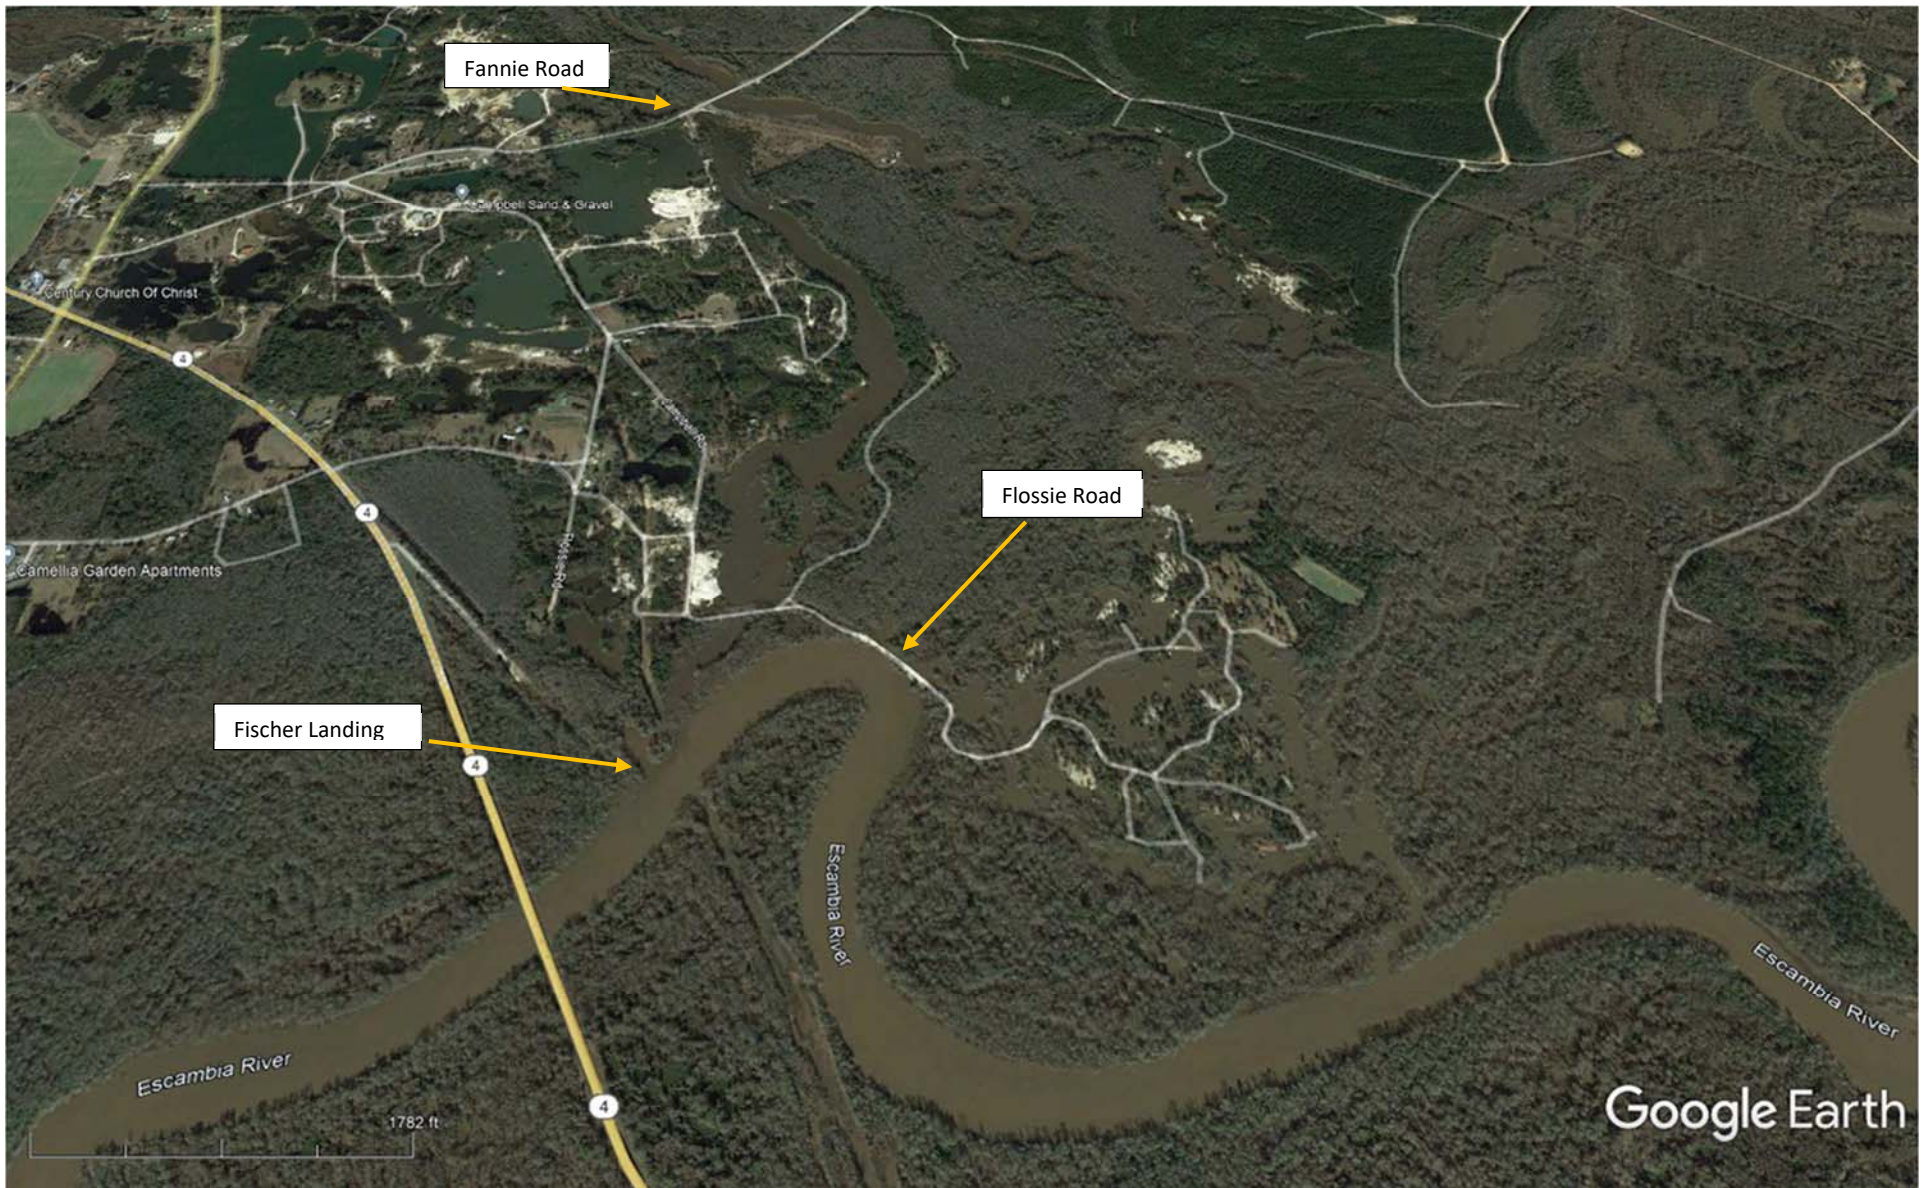
2019 Aerial Photograph

January 2019: High Water event. No sand bars visible. Water appears to be at flood stage or higher (> 17 feet). The Fischer landing and boat ramp is under water. The east sand mine area is under water. The west sand mine appears to remain separated from Big Escambia Creek, but the water level is still high. The Flossie Road bridges are still above water.
