Fischer Landing Town of Century Sedimentation Study June 2022

Water Resource Associates, LLC

Annotated Aerial Photography of Sedimentation Study Area - 1940 to 2019

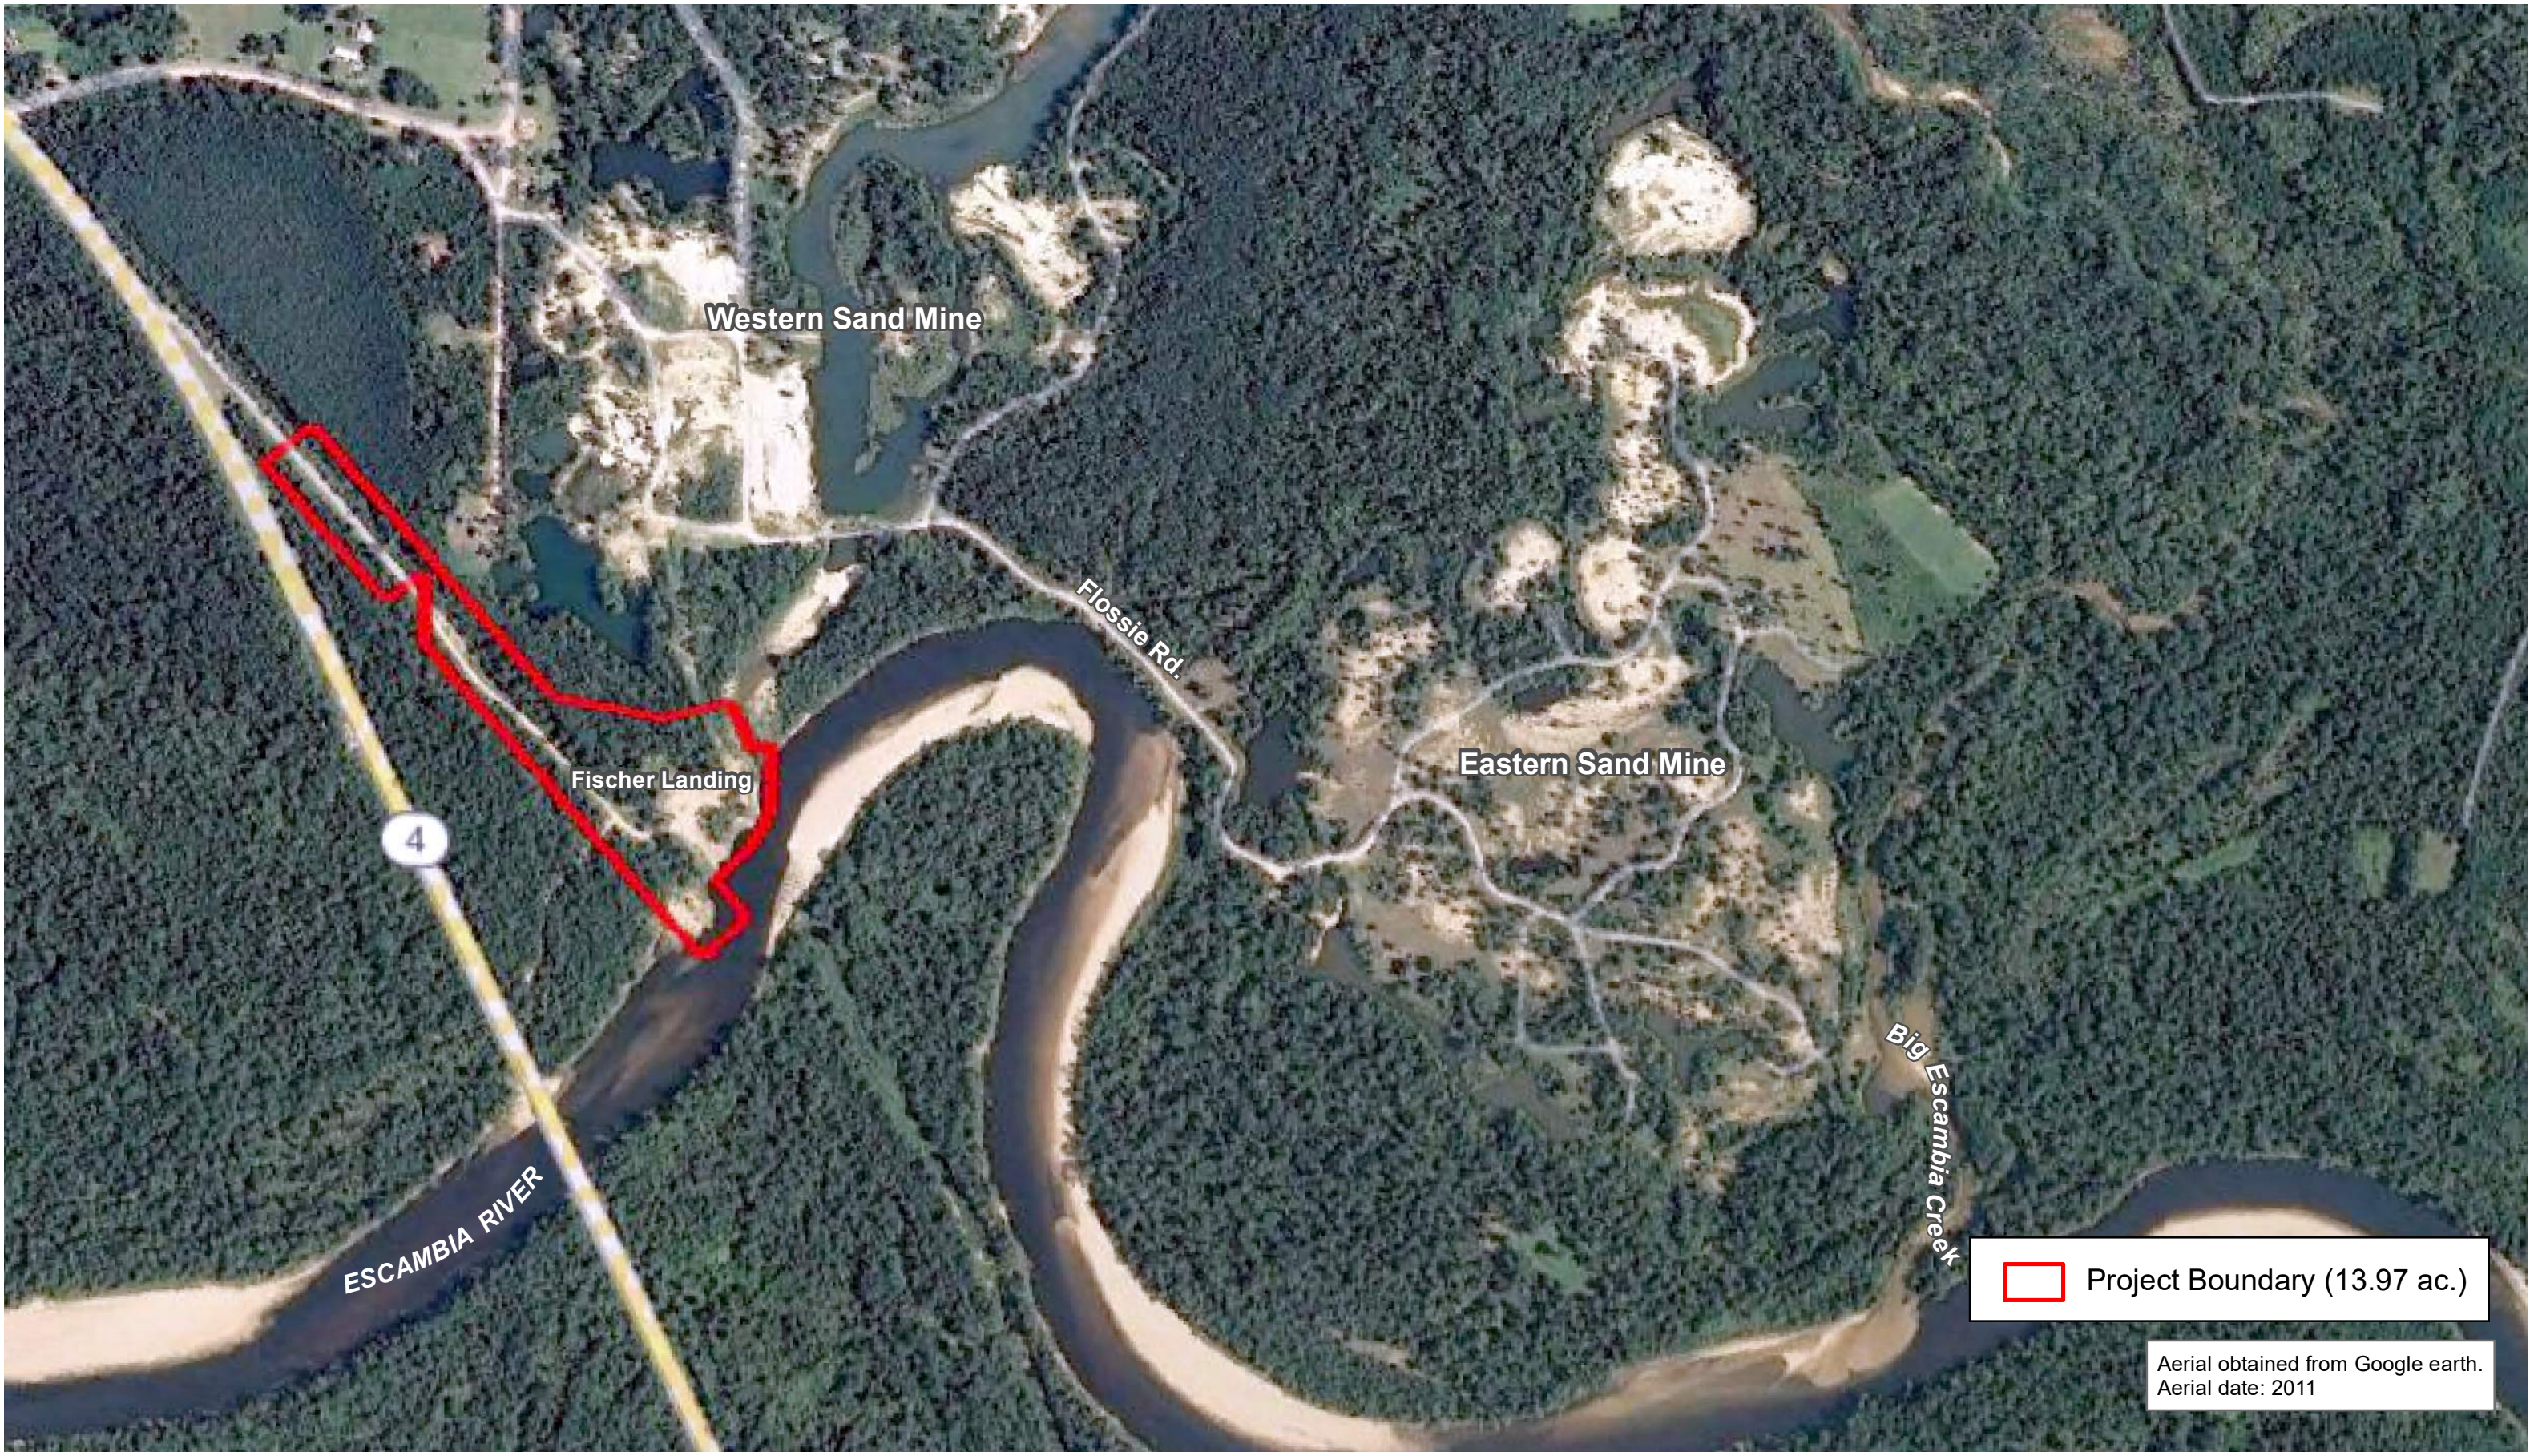
Exhibit 3: Fischer Landing

During site reviews at different water stages when the river was within its banks, WRA did notice a counter current in the vicinity of the boat ramp. The water movement of the river is downstream within the main channel in this location. However, the counter current originates at the bridge rubble that deflects part of the current up stream close to the east bank. The counter current rejoins the downstream flow around the location of the old boat ramp. During low water periods, this counter current could provide conditions for sediment to settle in the area of the new boat ramp. This will need to be further researched.
