**Streambank Erosion in the Pensacola Bay  
and Perdido Bay Watersheds**

May 31, 2023

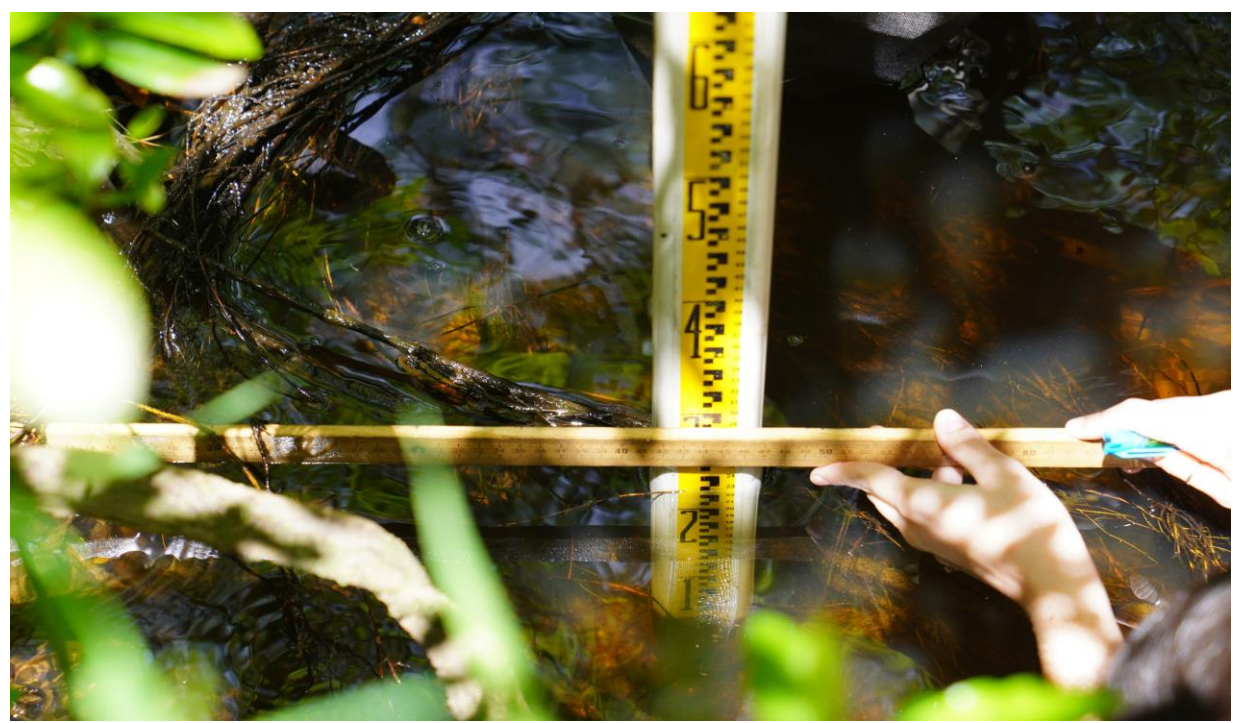
**Figure 2:** The horizontal distance between the vertical surveying rod and the face of the bank being measured using a ruler and line level.

Bank profiles were measured by installing a vertical toe pin (1.5m long section of rebar) in the stream at the toe of the bank. A surveying rod with a rod level was held vertically atop the toe pin, serving as the y-axis for the profile. Horizontal distances, the x-values, were measured between the vertical surveying rod and the face of the bank using a ruler and line level to ensure horizontal alignment (Figure 2). Measurements were taken at varying intervals along the vertical surveying rod depending on the contour of the bank. At the twenty existing sites, streambank profiles were measured once and compared to initial profiles of the bank, which were originally surveyed using this same method, to determine the average annual erosion rate over an extended period of time. At the ten newly established sites, bank profiles were surveyed at the beginning

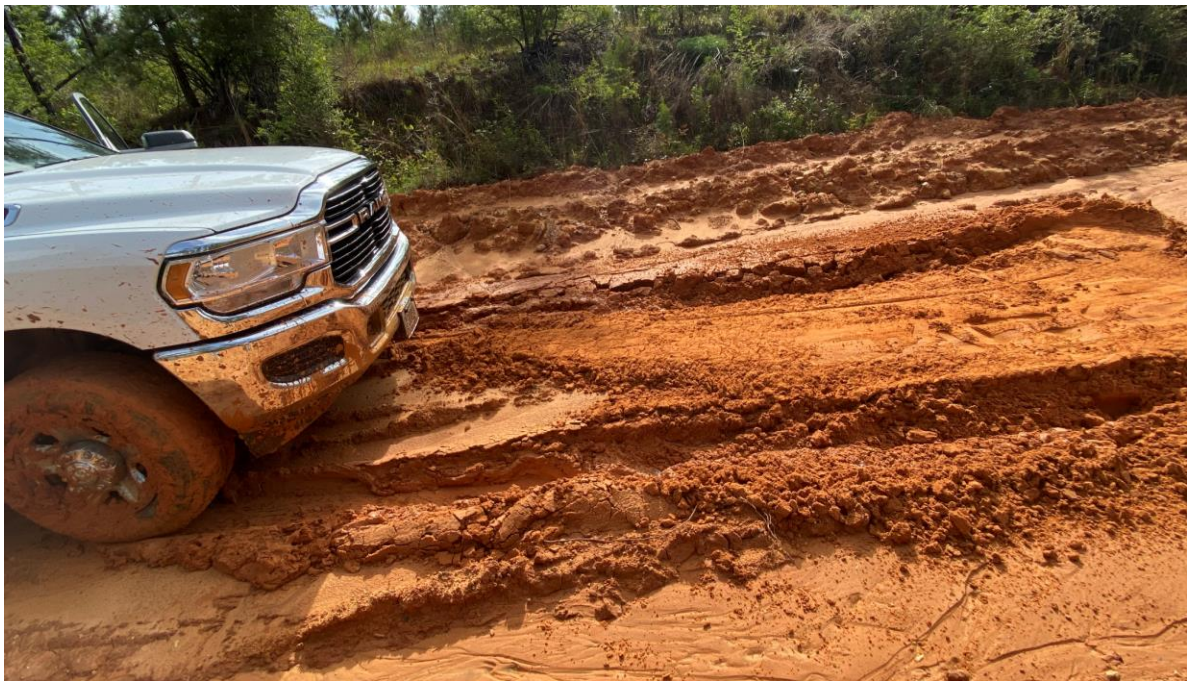
**Figure 3:** Inaccessible roads leading to site PB09, where a repeat bank profile measurement was unable to be collected.

and end of the six-month project period, with the exception of one site (PB09) due to a loss of accessibility (Figure 3). Local land use and site characteristics, including bank height, bank vegetation cover, and stream order, were also recorded at each site. The height of the study bank was determined by subtracting the height of the foot of the study bank from the height of the top of the study bank. The percentage of the bank covered by vegetation was approximated by averaging the visual estimations provided by two or three independent observers. Stream order was determined by reviewing topographic maps of each site and evaluating their positions within their respective river systems.
